Recent Hanford Inspection Studies

Allan F. Pardini PNNL
Dennis R. Weier PNNL
James M. Alzheimer PNNL
Wesley H. Nelson AREVA
August 26, 2009

DST Tank Inspections

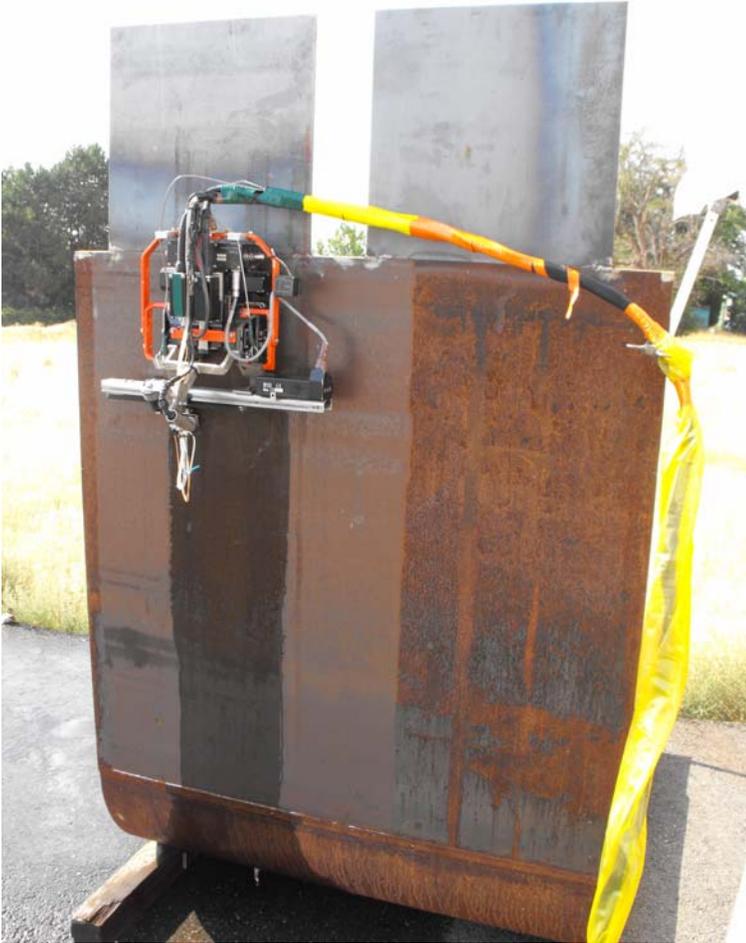
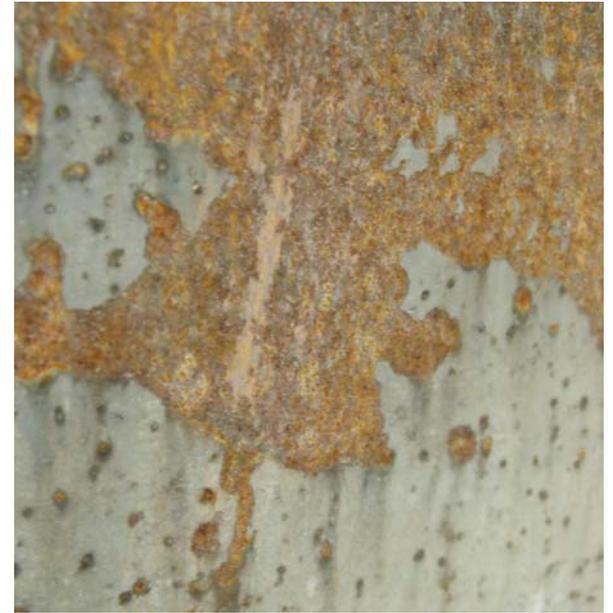
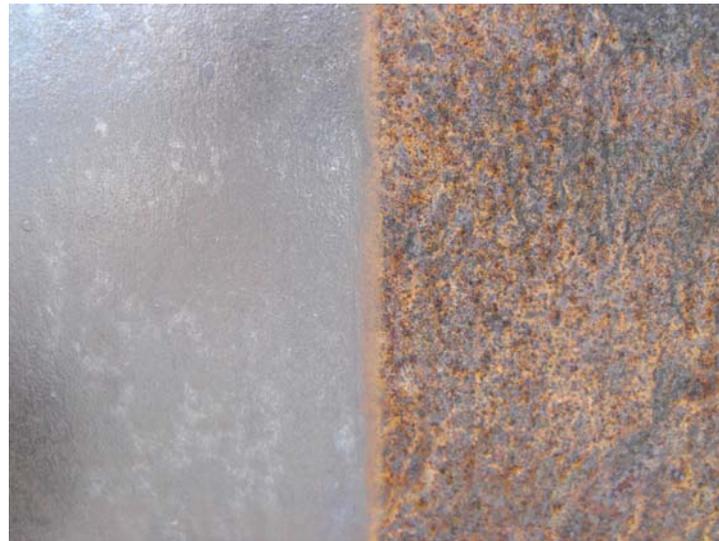
Mockup Study

- Currently working on the mockup studies

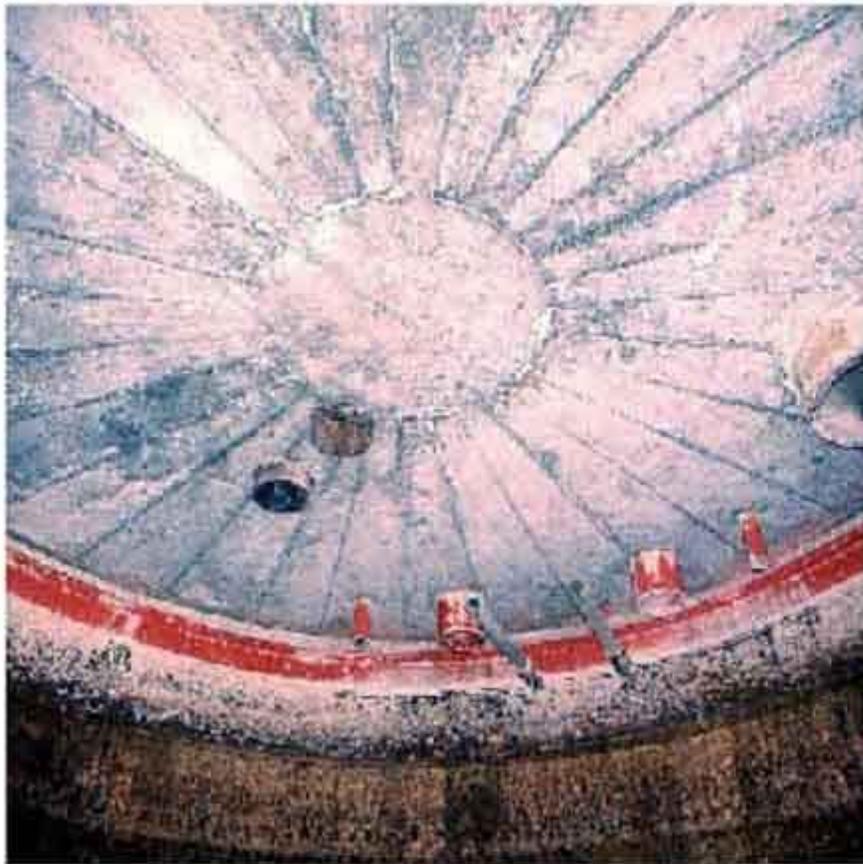
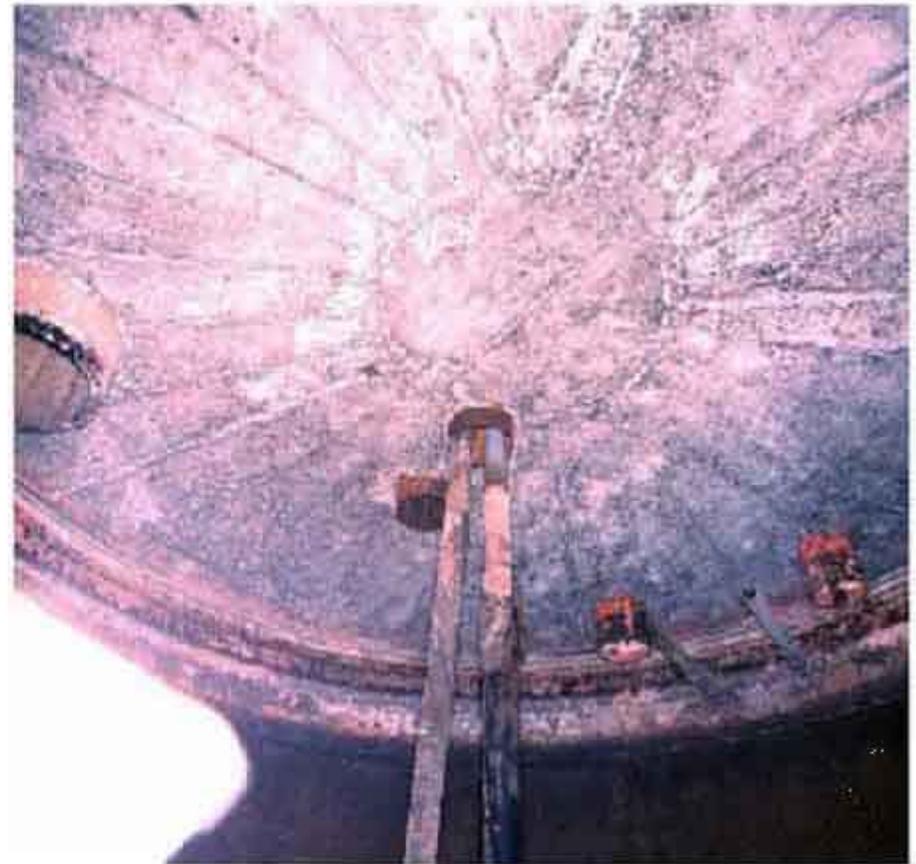
Tank Domes Showing Form Seams and Access Risers

- ▶ Dome surfaces were not fabricated with crack detection in mind
- ▶ Lots of seams from concrete forms
- ▶ Surface anomalies from repair of voids during initial concrete pour
- ▶ Surface changes due to environmental affects

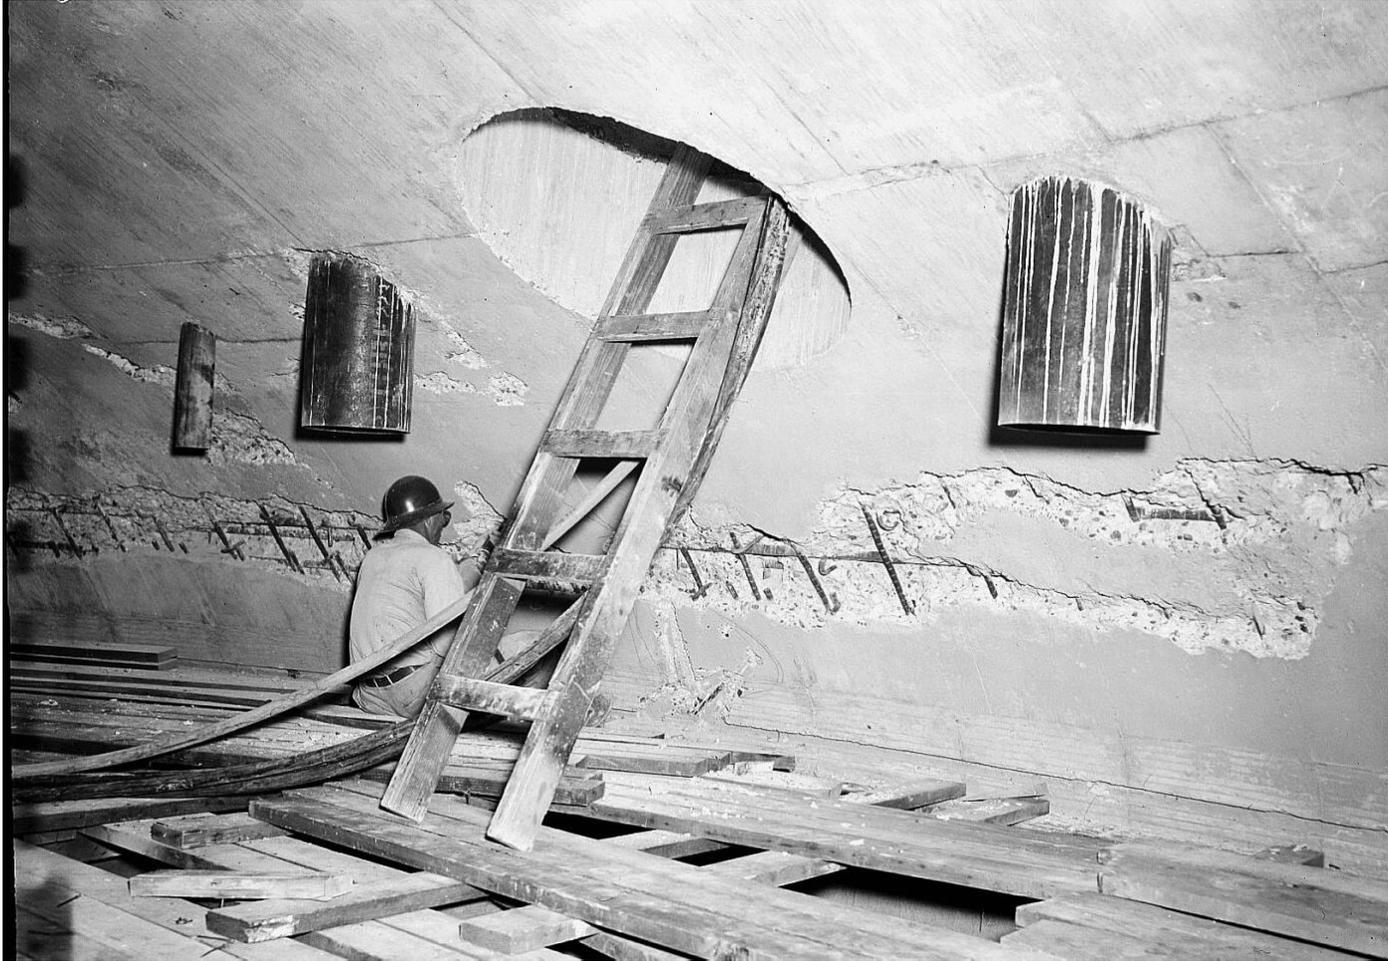
Construction Repair To Single Shell Tank Dome Concrete

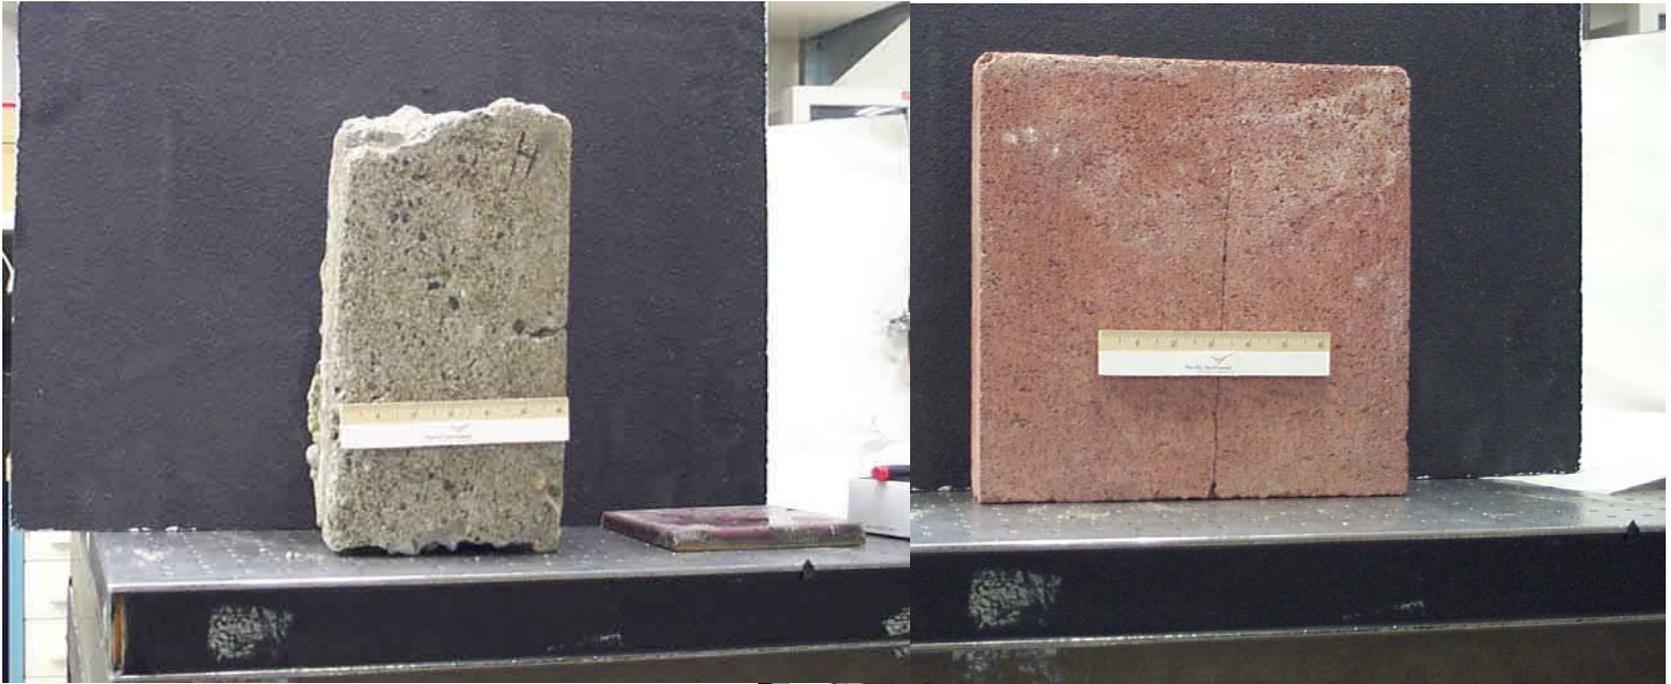
Samples of cracked concrete used for photographic studies

- ▶ Prepared cracked concrete samples
- ▶ Took a series of digital photos to investigate:
 - Required camera resolution
 - Effects of lighting types and lighting angles
 - Effects of angle between camera and surface
 - Ultraviolet and Infrared imaging
 - Polarizing filters
 - Application of various imaging filters

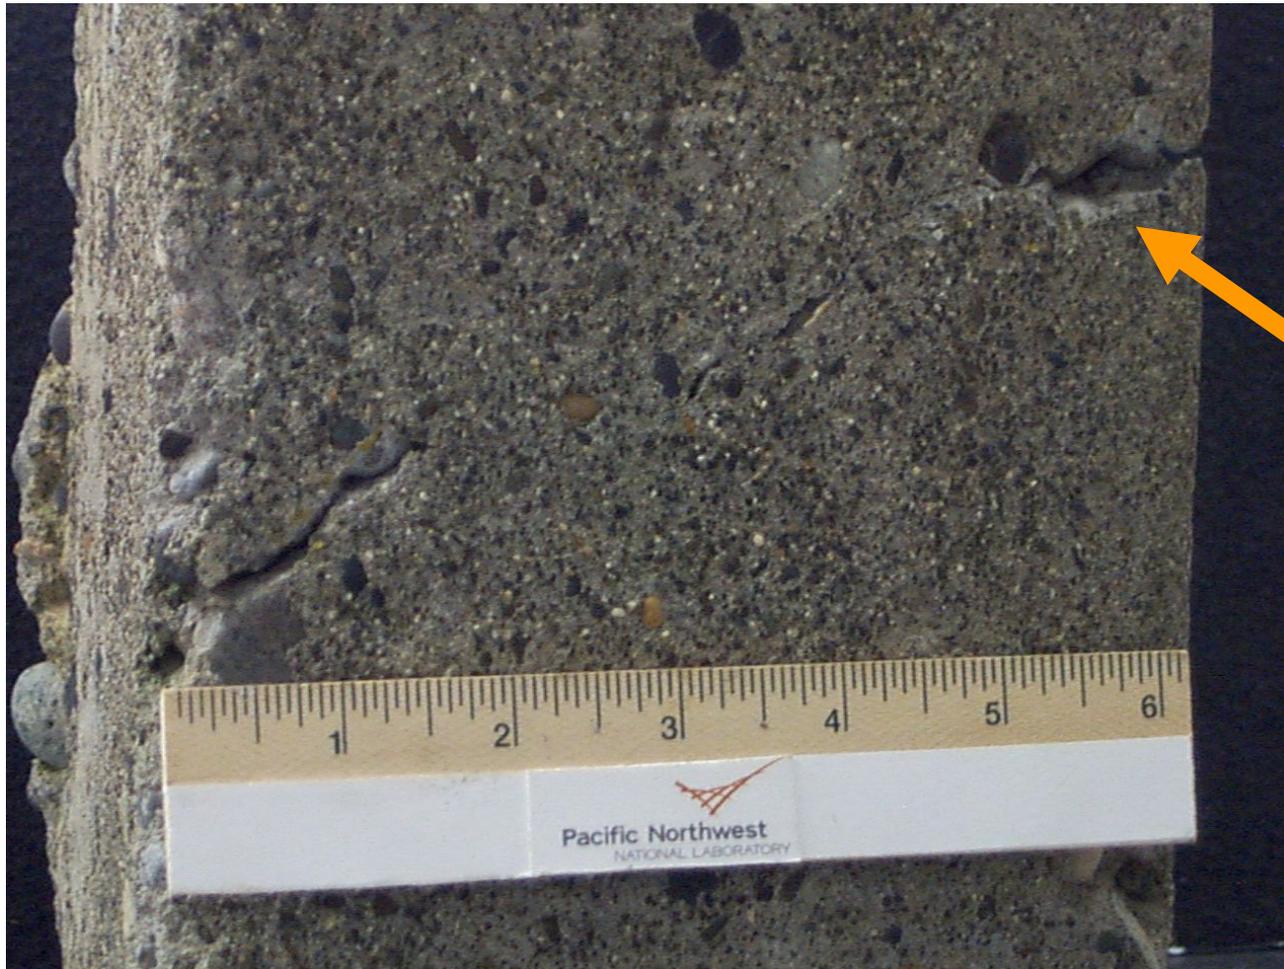
Chips
along
cracks at
tensile
surface

- ▶ Cracks on dome surface would be due to tensile failure of concrete
- ▶ Cracks of 1/16 inch width indicate permanent rebar deformation
- ▶ Cracks will likely have missing chips at multiple locations along their length

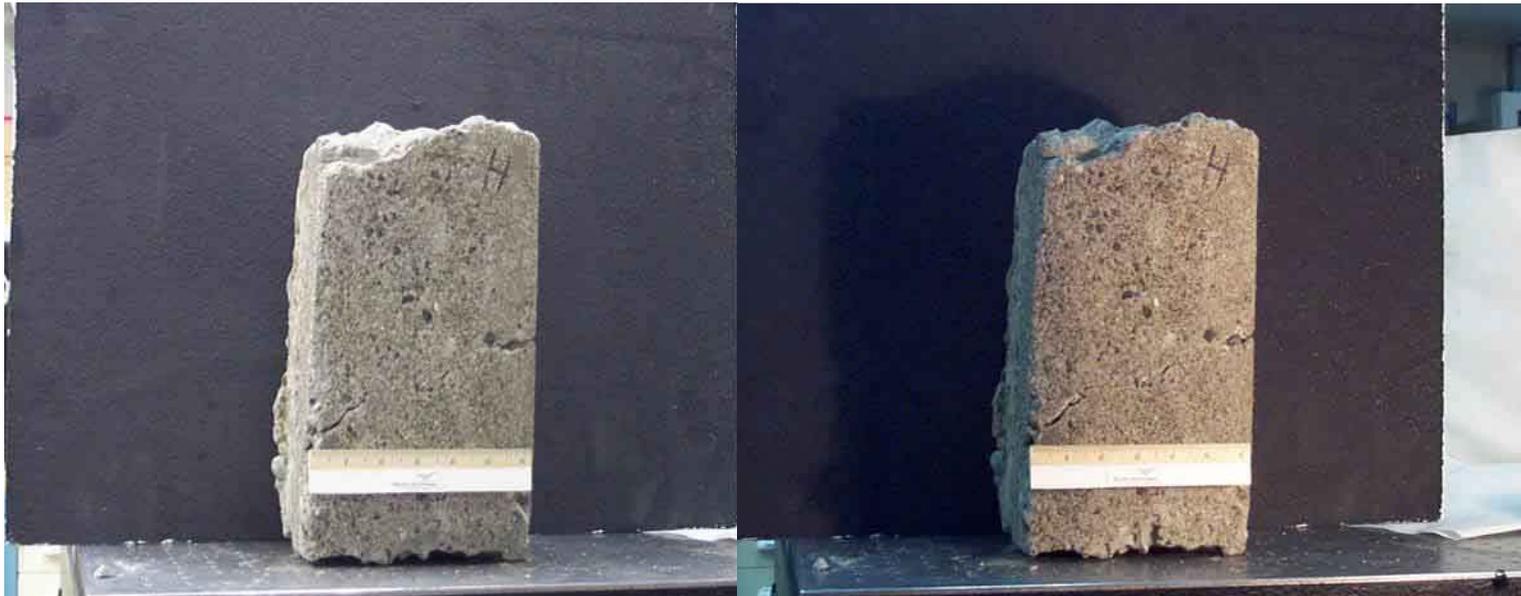
Effect of Lighting Type on Crack Detection

Diffuse Fluorescent Light

Tungsten Light Source

- ▶ Detection of 1/16 inch wide cracks appears challenging but achievable with available cameras
- ▶ Proper lighting is critical to any crack detection
- ▶ Changing lighting angles may aid in detection
- ▶ Ultraviolet and infrared imaging did not improve detection
- ▶ Polarizing filters did not improve detection
- ▶ Imaging filters deserve further investigation
- ▶ Getting the camera and lights close enough and at the optimum orientation of the dome surface will be challenging
