DOE Office of Waste Processing
Technical Exchange

Tanks 5 and 6 Chemical Cleaning

**Washington Savannah River Company
May 19, 2009**

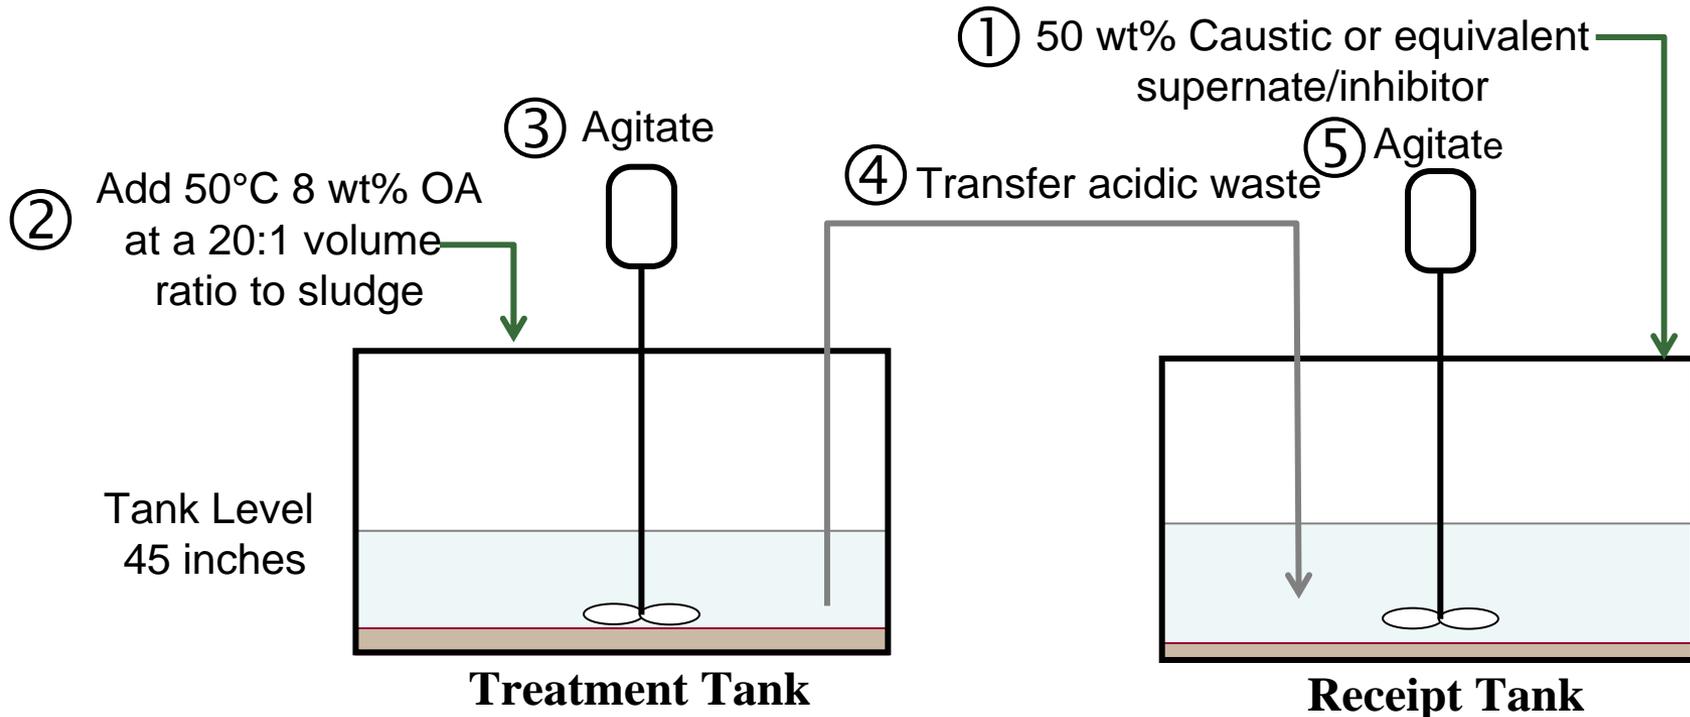
Process Steps – First Acid Strike

- Tk 34 supernate transferred to Receipt Tank for pH adjustment of acid waste stream
- Add OA at 20:1 volume ratio of acid to sludge from tankers at 50°C
- SMPs operated in Treatment Tank to aid dissolution and suspension
- Acid waste stream transferred to Receipt Tank
- Standard Slurry pumps operated in Receipt Tank to enhance pH adjustment

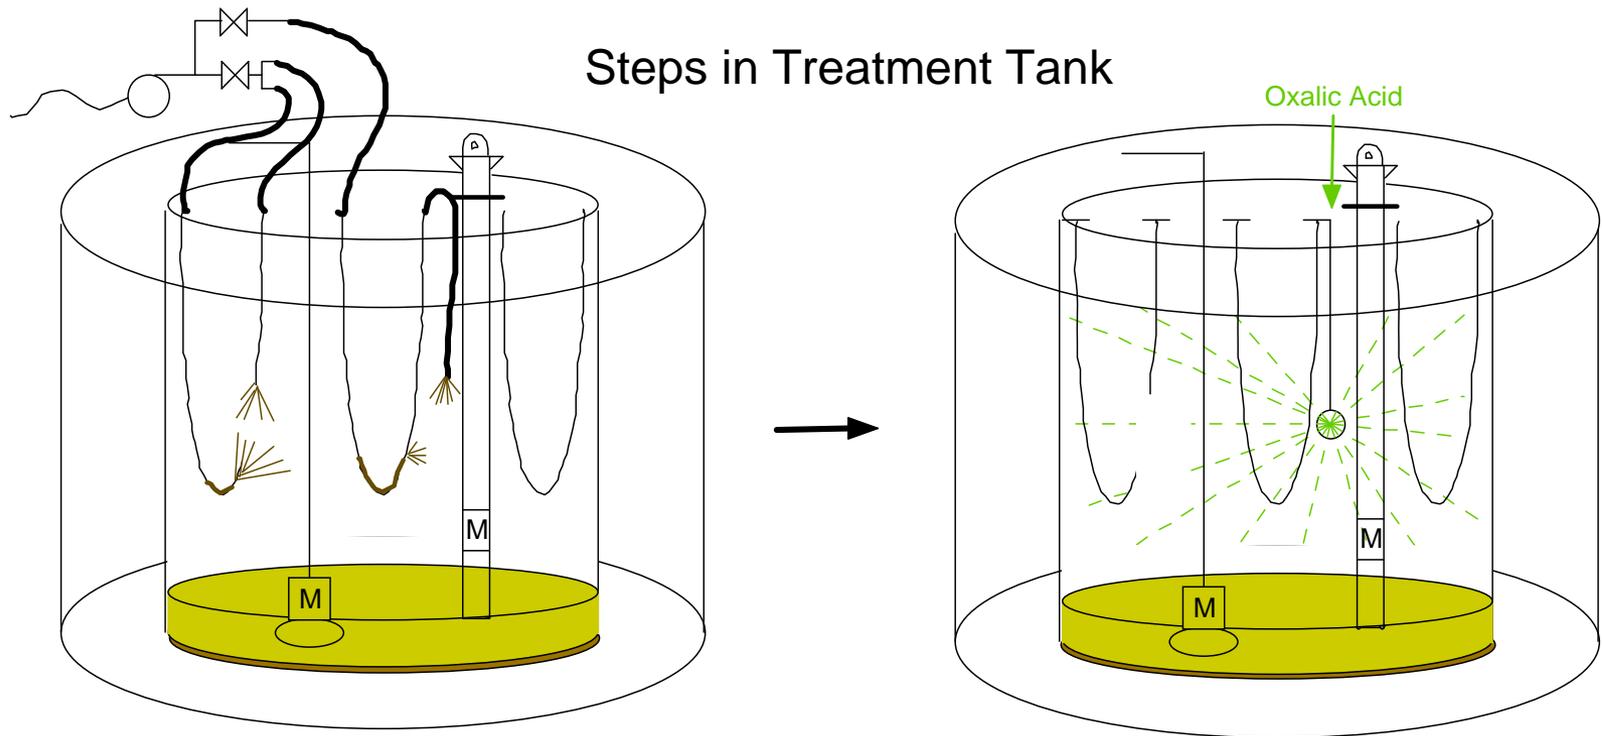
Process Steps – Coil Flush and Third Acid Strike (Acid Spray Wash)

- Flush failed cooling coils
- Tank 34 supernate transferred to Receipt Tank for pH adjustment of acid waste stream
- Add OA at 13:1 volume ratio of acid to sludge via spray wash and provide soak time
- Acid waste stream transferred to Receipt Tank with slurry pumps running

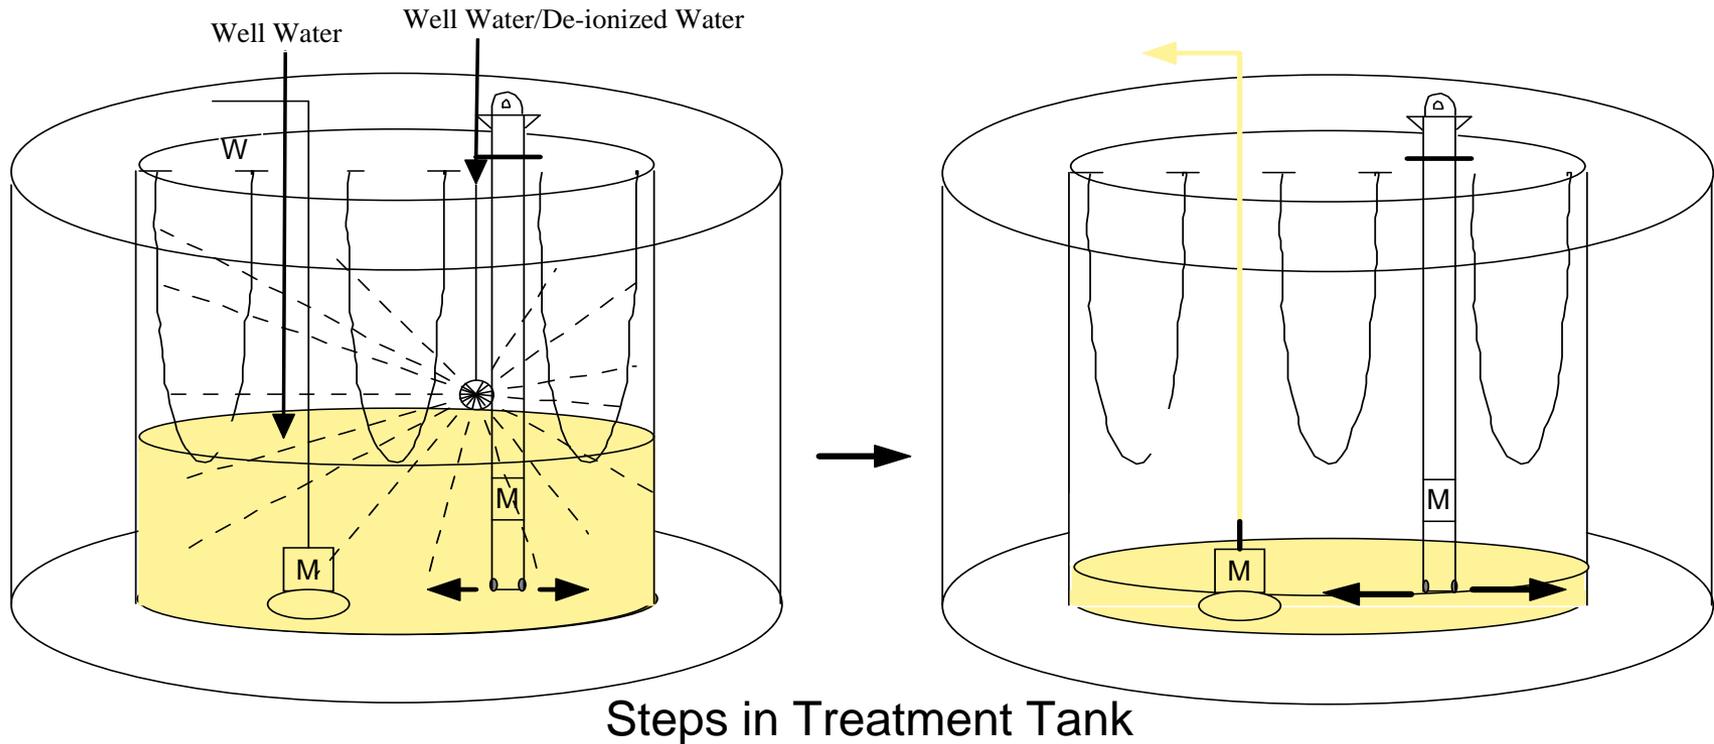
Process Steps – Water Wash

- Spray wash primary tank interior with water
- Add additional water and run SMPs
- Transfer wash water solution to Receipt Tank

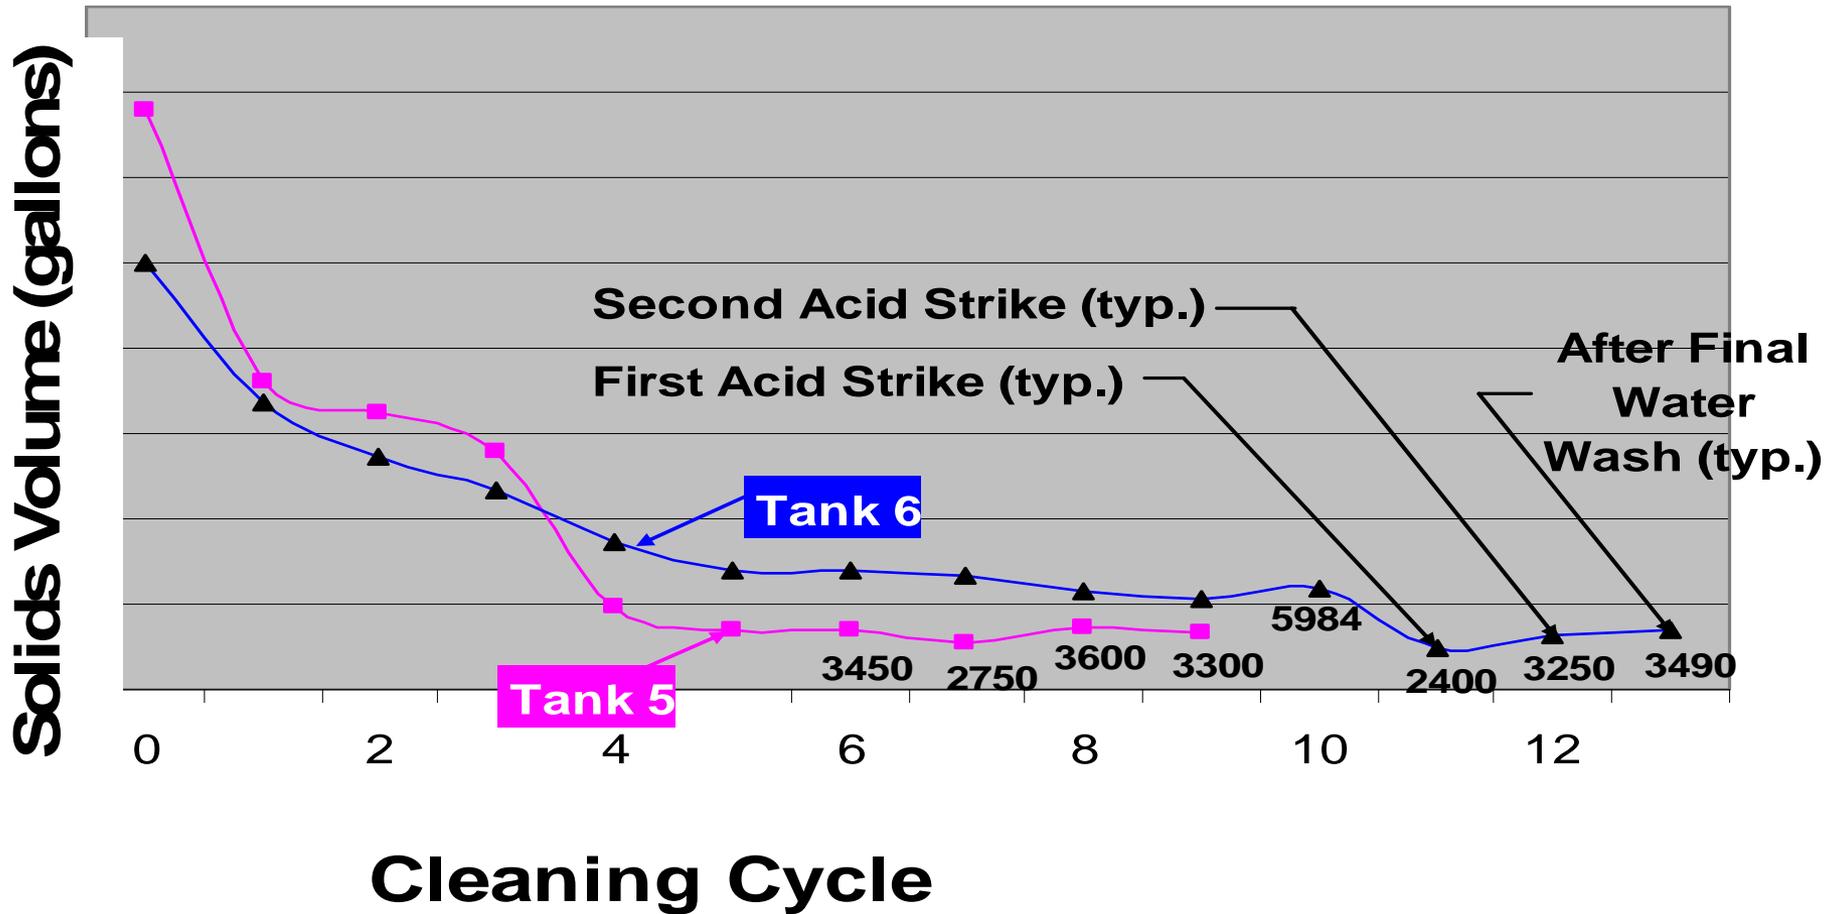
Solids Volume Remaining

- **Process flowsheet has been completed for both Tanks 5 and 6.**
- **Residual solids volume decreased after first strike but increased after the second strike (new solids formed)**
- **Volume for Third Acid Strike reduced to minimum required for Acid Spray Wash**
- **First acid strike in Tank 5 was not as effective as expected, pH of acid waste solution in Tank 5 after first acid strike was 5 versus expected value of 2 (probable cause is higher levels of basic ions in sludge than expected)**
- **Process sampling is in progress to determine composition of residual solids**

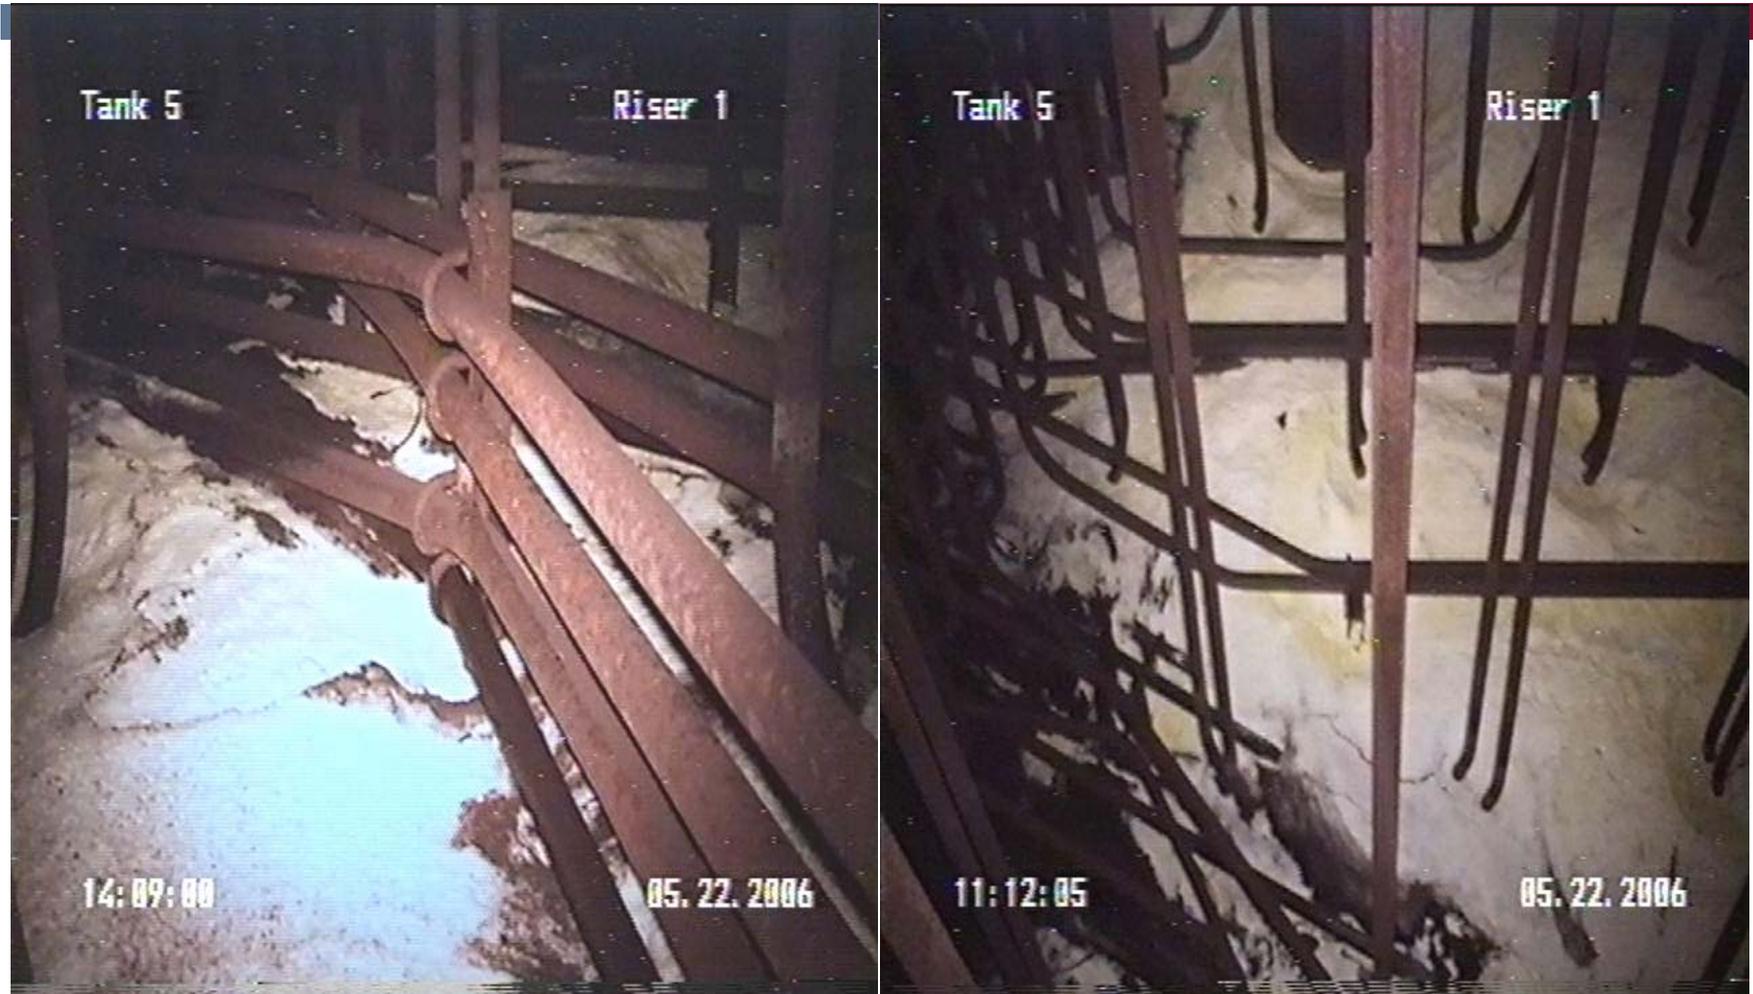
Tank 5 – After Bulk Sludge Removal, Prior to Mechanical Sludge Heel Removal

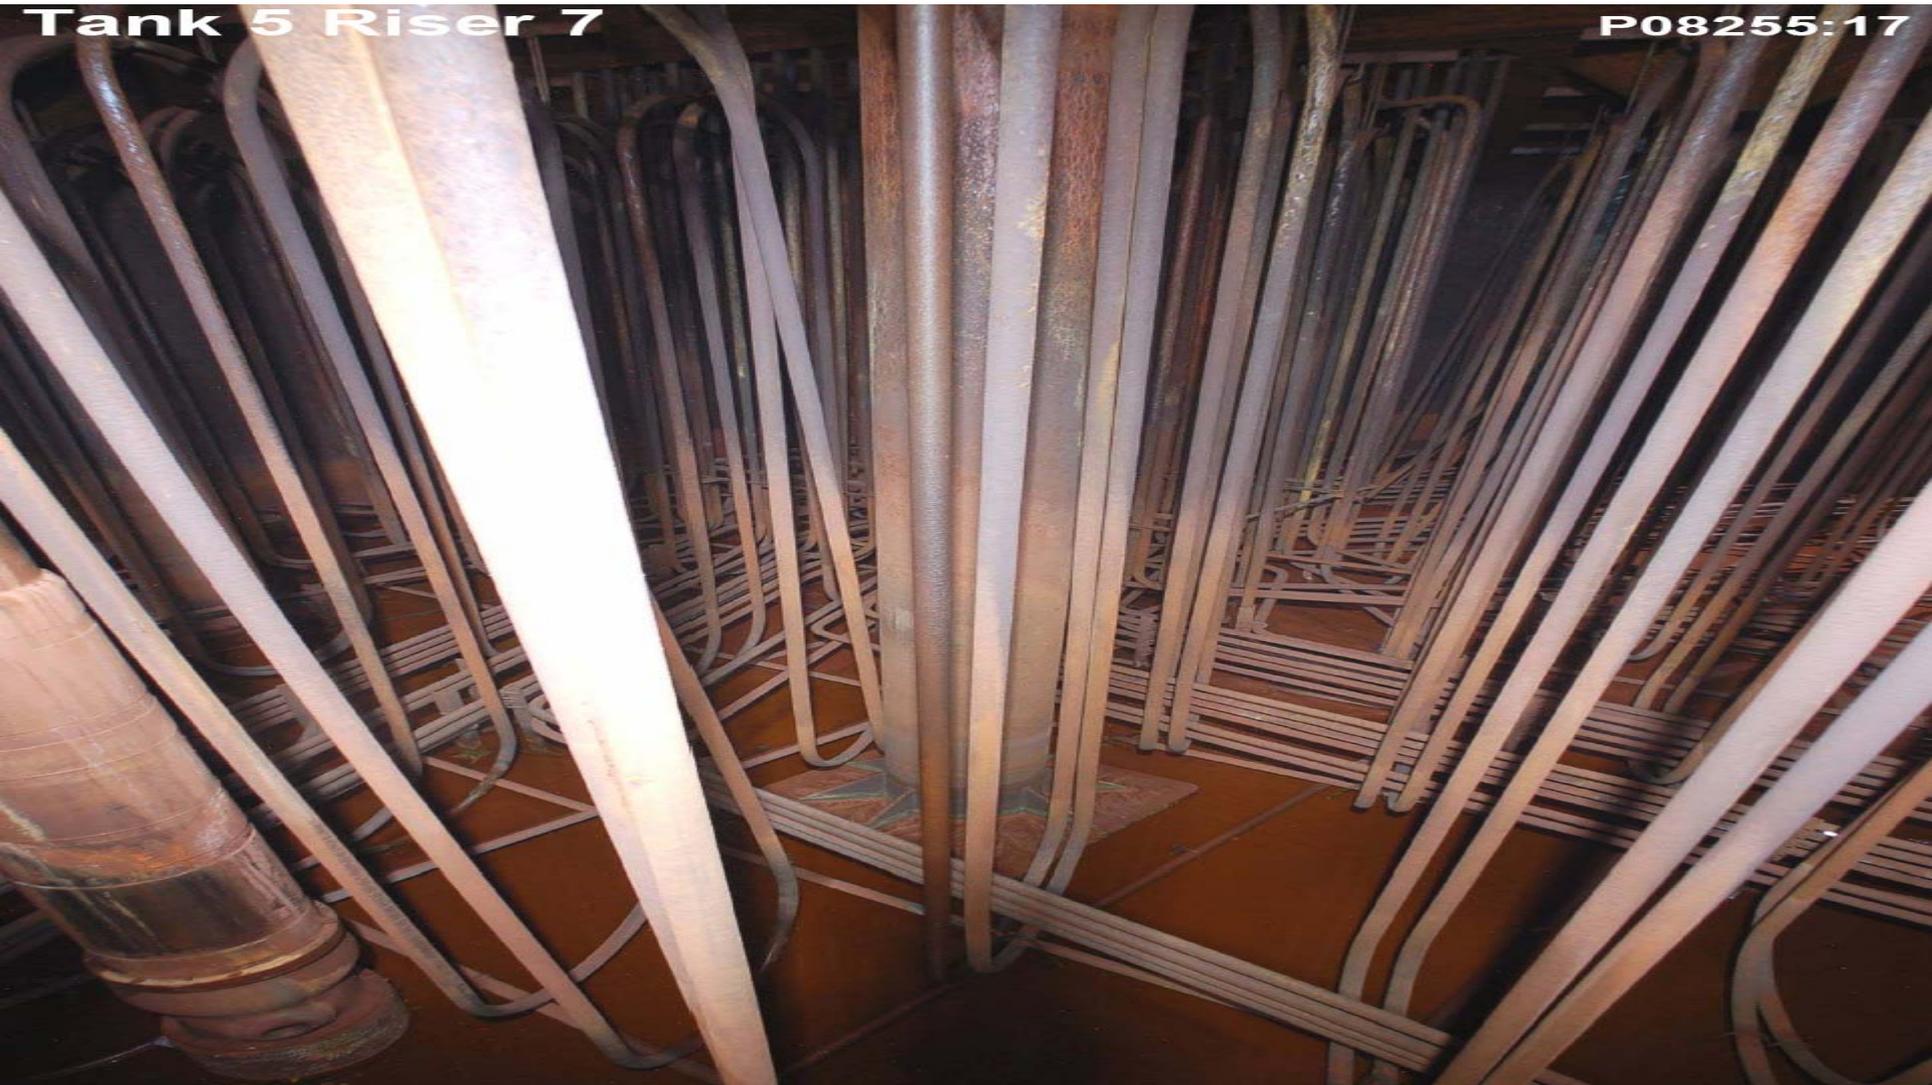
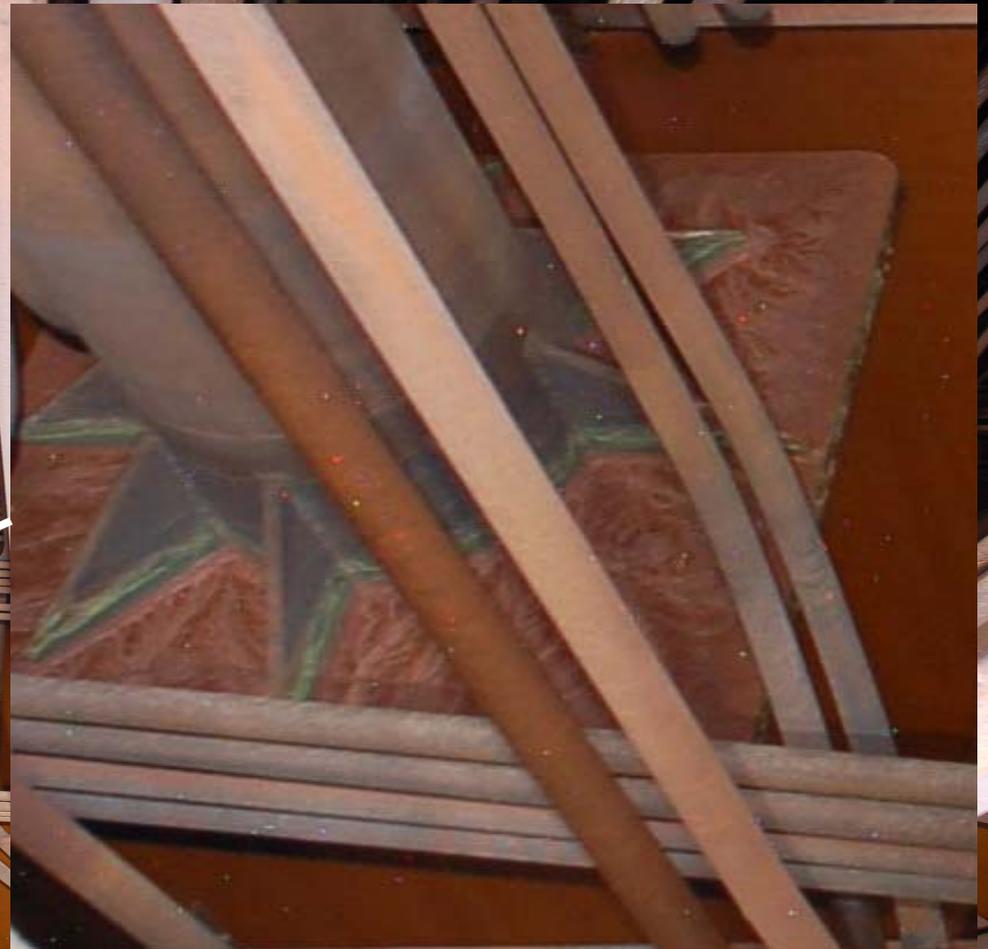
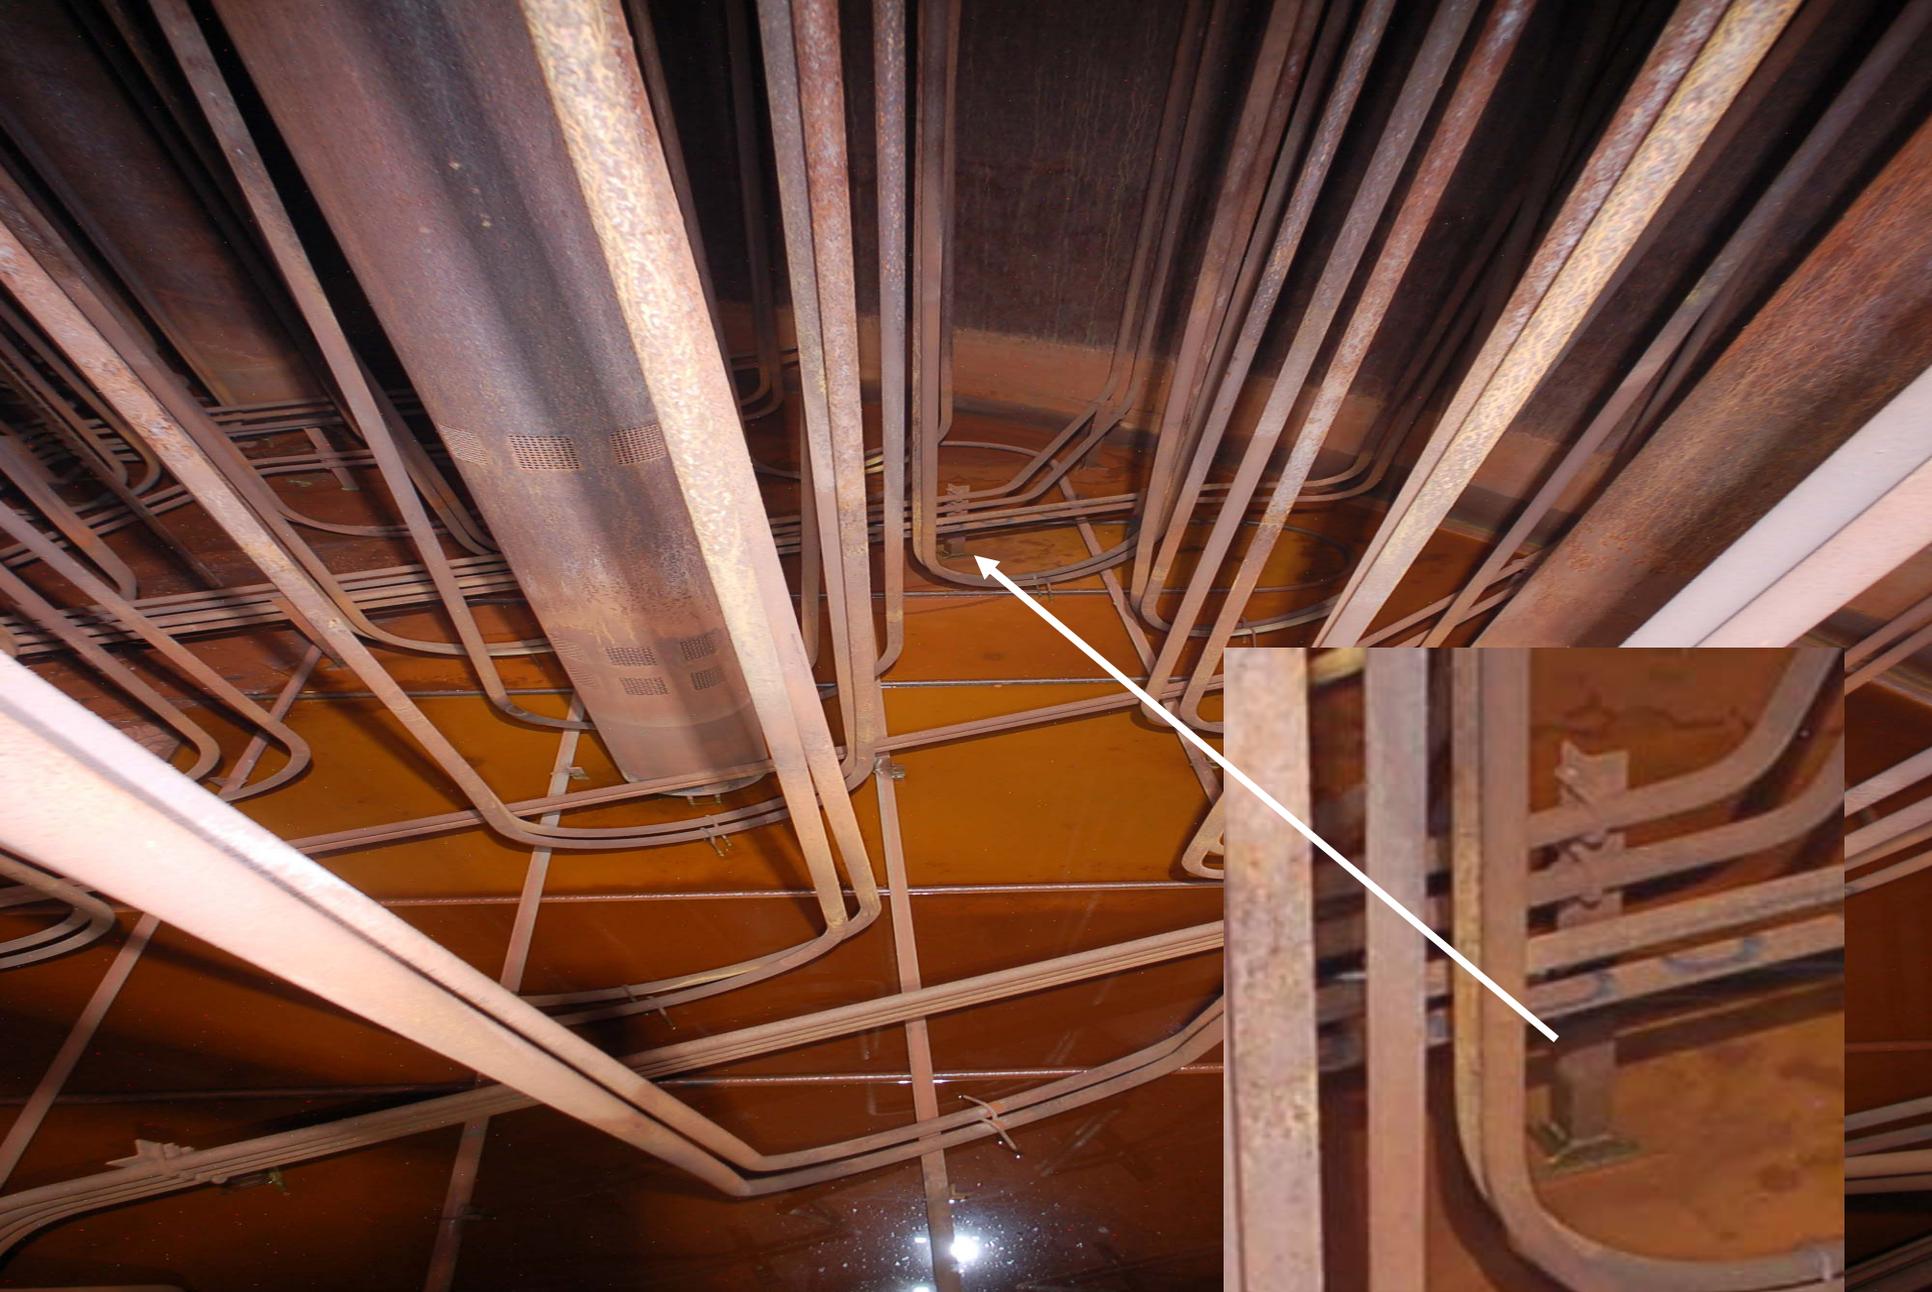
Tank 5 Interior Pictures – After Chemical Cleaning

Base plate is
4.5" from tank
bottom

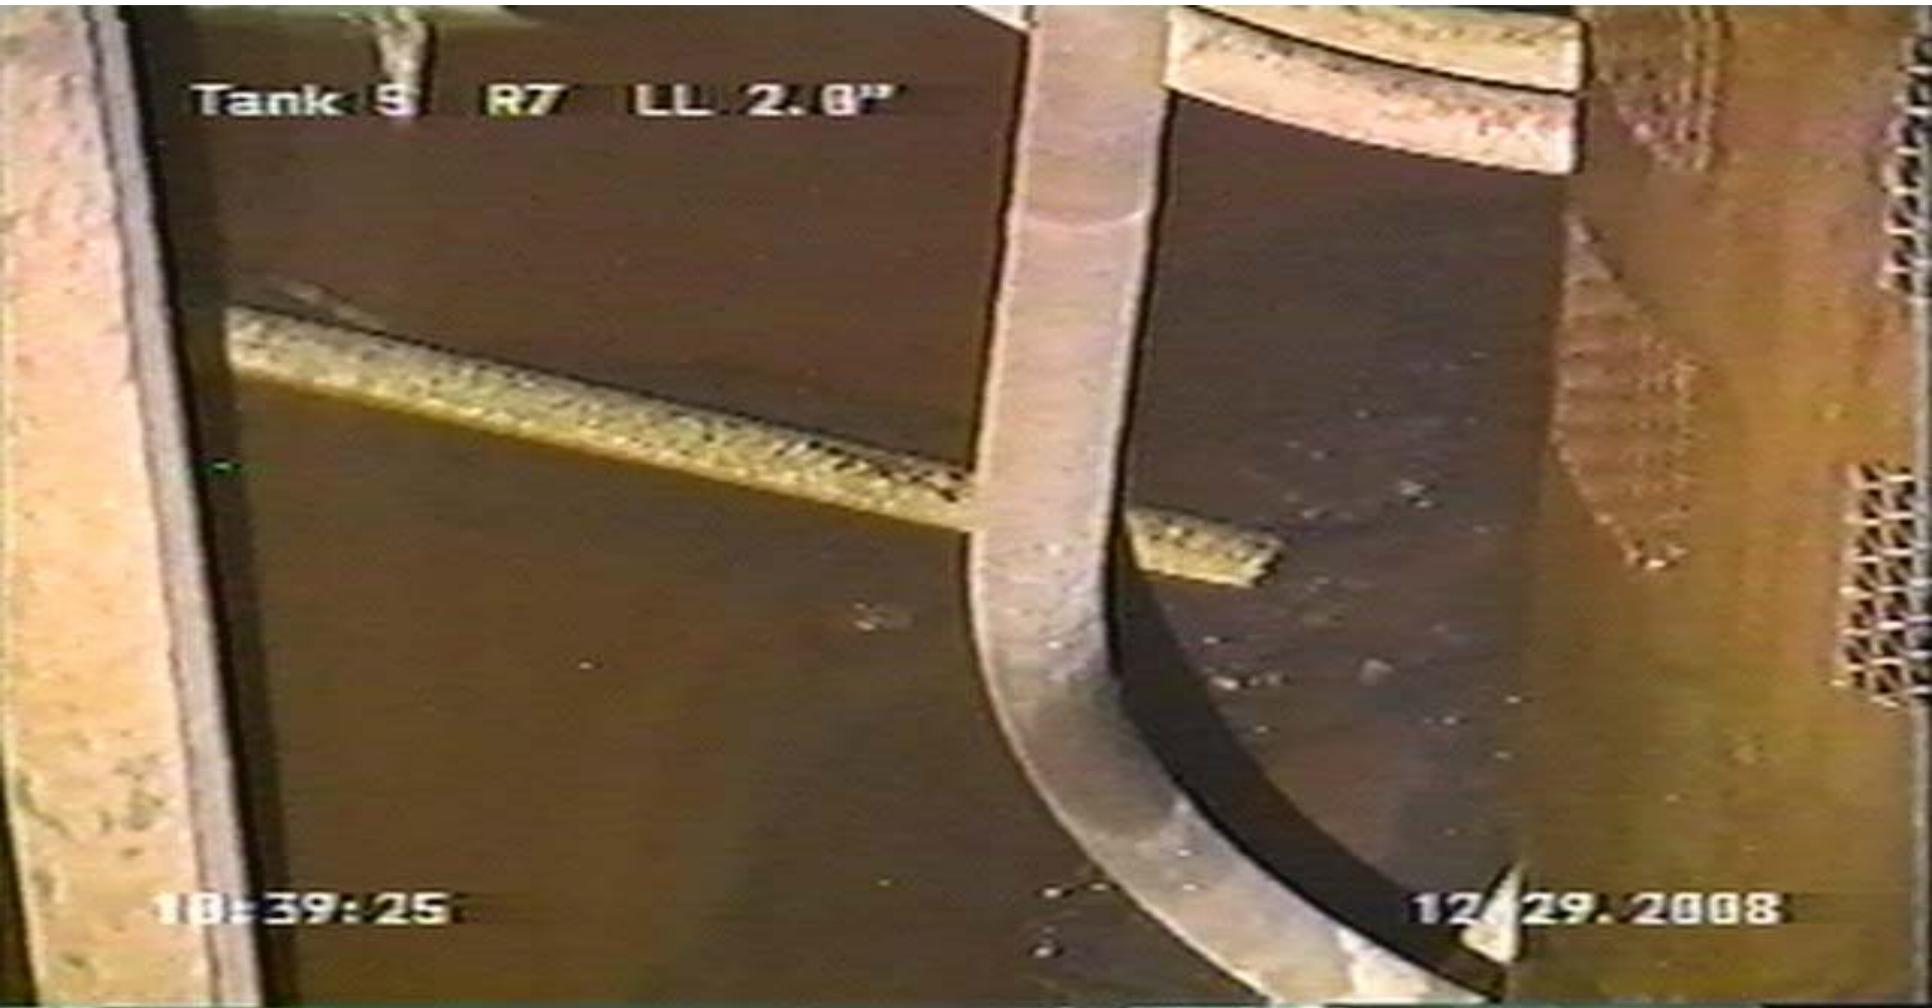
Tank 5 Interior Showing Remaining Solids – After Chemical Cleaning
