DOE Office of Waste Processing
Technical Exchange

F - Tank Farm Closure Annulus Cleaning

Rudy Jolly/Donald Thaxton
Lead Project Engineer
F- Tank Farm Closure Projects
Washington Savannah River Company

May 19, 2009

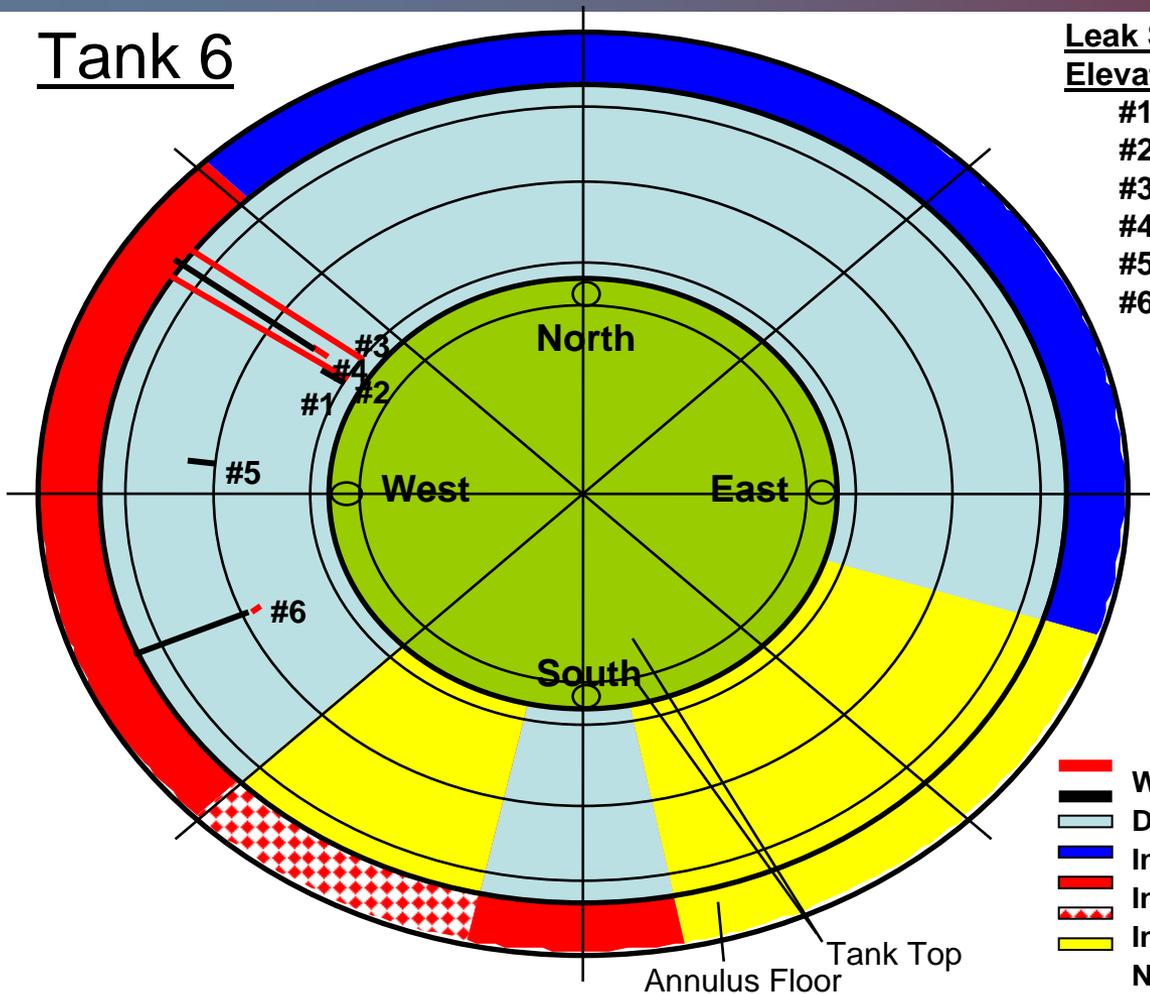
Typical Leak Site Locations

Tank 6

Leak Site	Location	Elevation
#1	W-24-N	233
#2	W-24.3-N	233
#3	W-26.5-N	233
#4	W-25-N	165
#5	W-7-N	129
#6	W-18.5-S	145

- █ Wet
- █ Dry
- █ Inspected Tank Wall
- █ Inspected Annulus & Confirmed Dry
- █ Inspected Annulus & Confirmed Wet
- █ Not Inspected but Believed Wet
- █ Can't Inspect

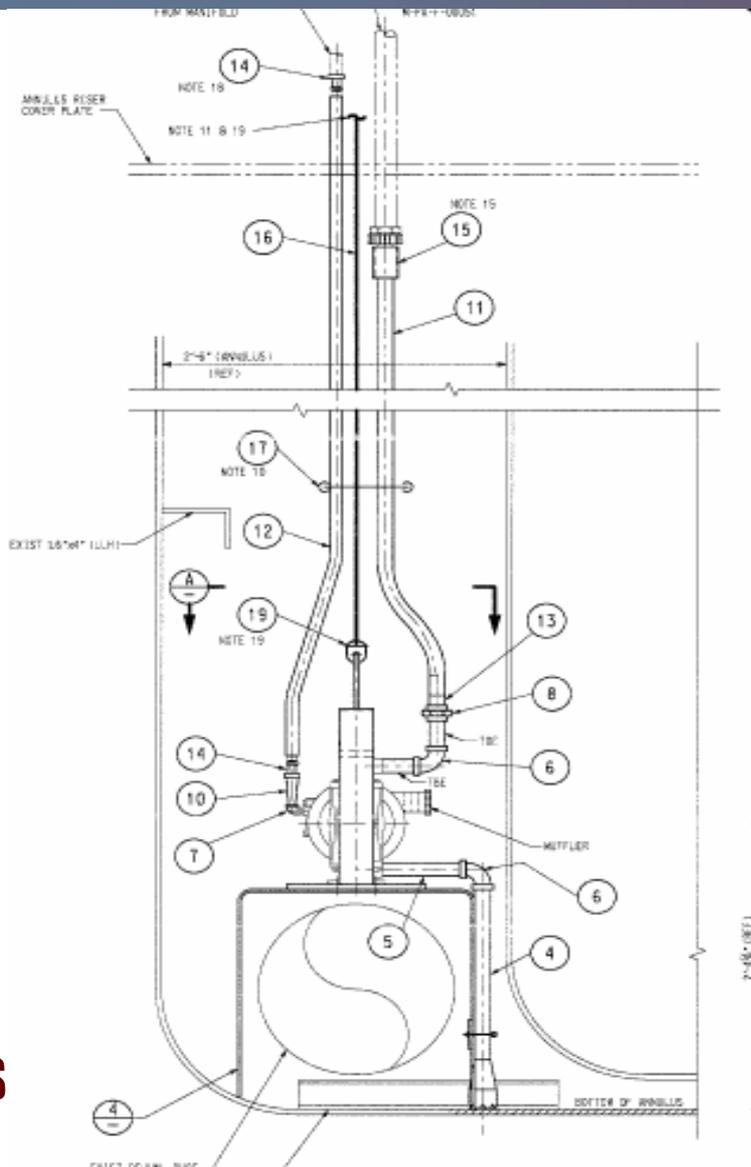
Tank Annulus Transfer Pump Design

- ALL-FLO Air Diaphragm Pump
 - 35 gpm @ 100 psi
- Utilizing Modified/Existing Transfer Line
- Speed Air Air Compressor (Air Supply)
 - 5.0 Hp
 - 16.5 cfm

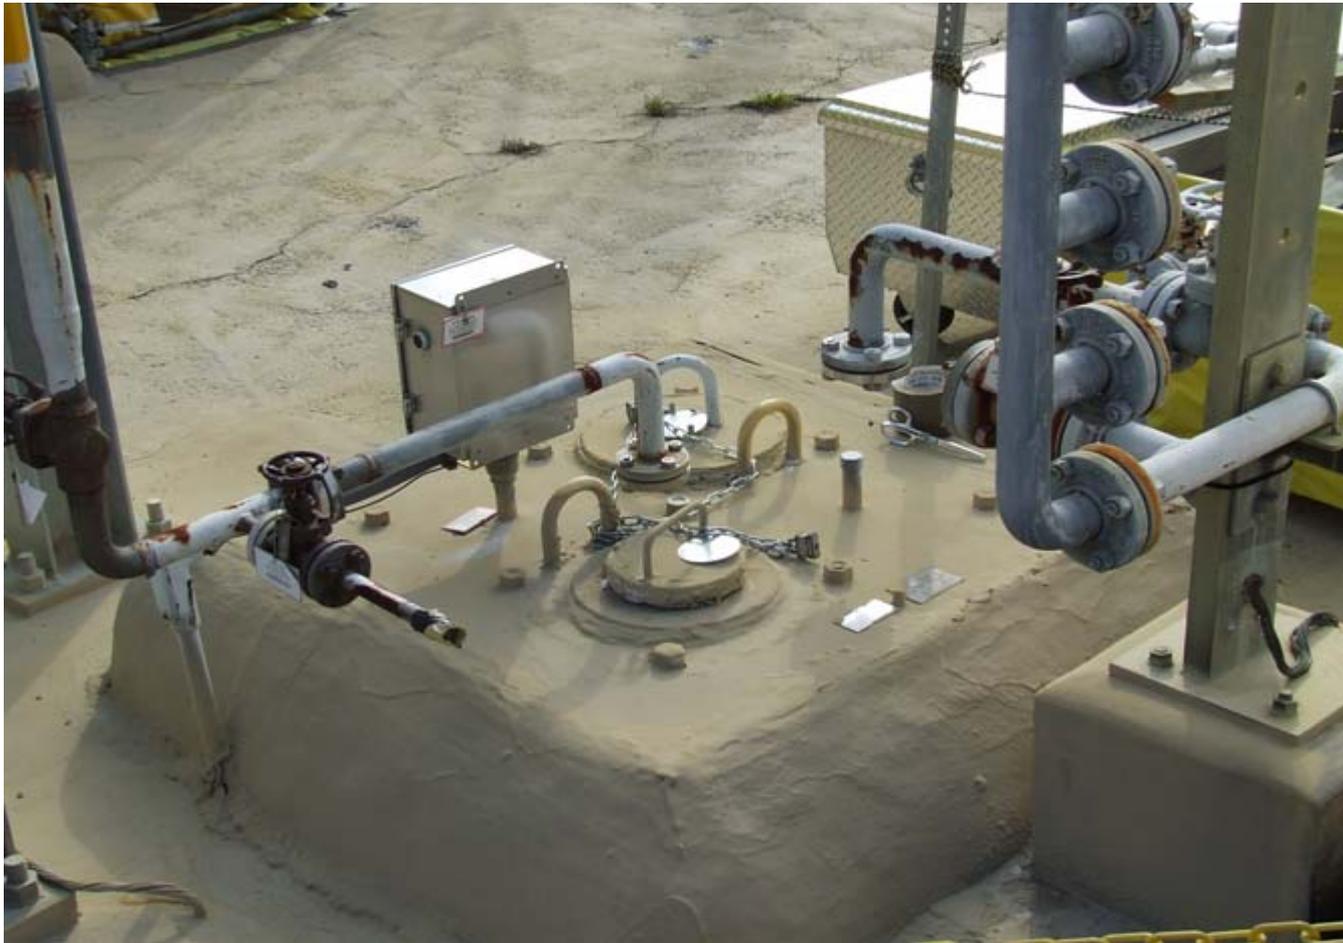
Tank Annulus Access Riser

Access Riser for Annulus Crawler – Typical of 4

- **Accomplished 100% cleaning of every leak site encountered to-date**
- **Utilized less water than planned**
- **Crawler performed as tested**
- **Next step is to flood annulus floor to up to 3” (~1000 gallons) to dissolve remaining salt**
- **Pump dissolved material to back to primary tank**
- **Caution with access risers varying in size/diameter which caused minor difficulty with crawler installation and removal.**

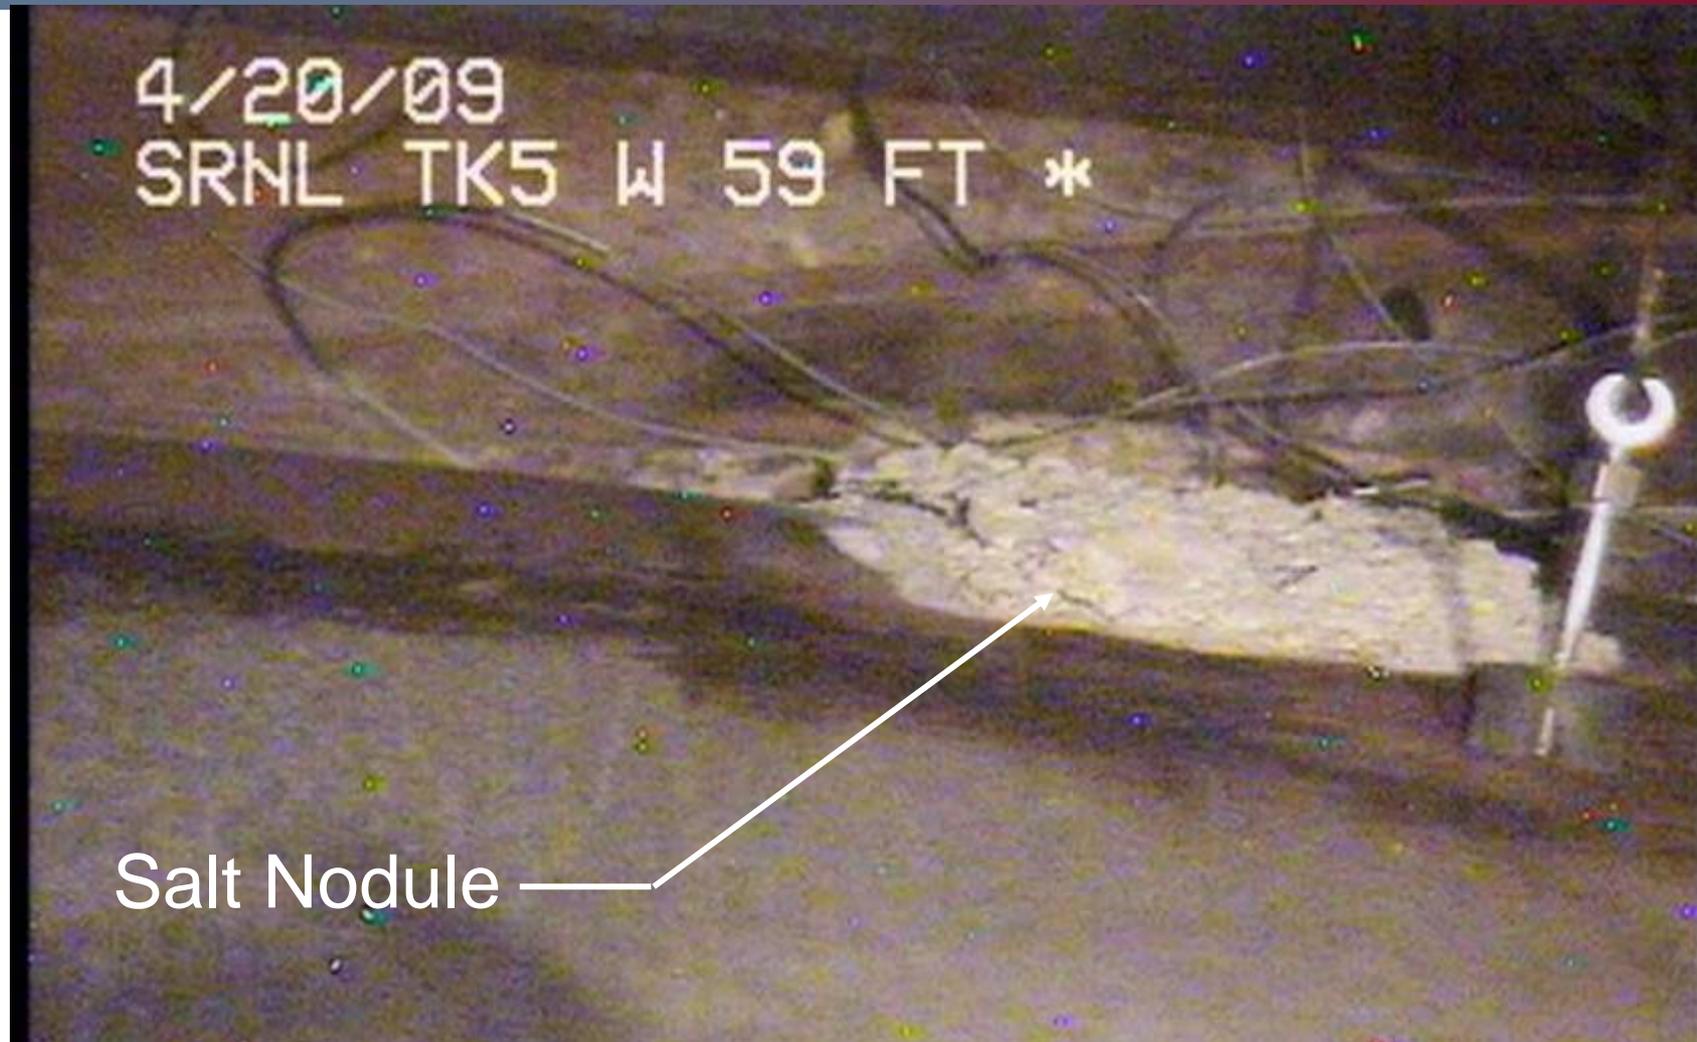
Tk 5 West Riser Leaksite (Before)

Salt Nodule

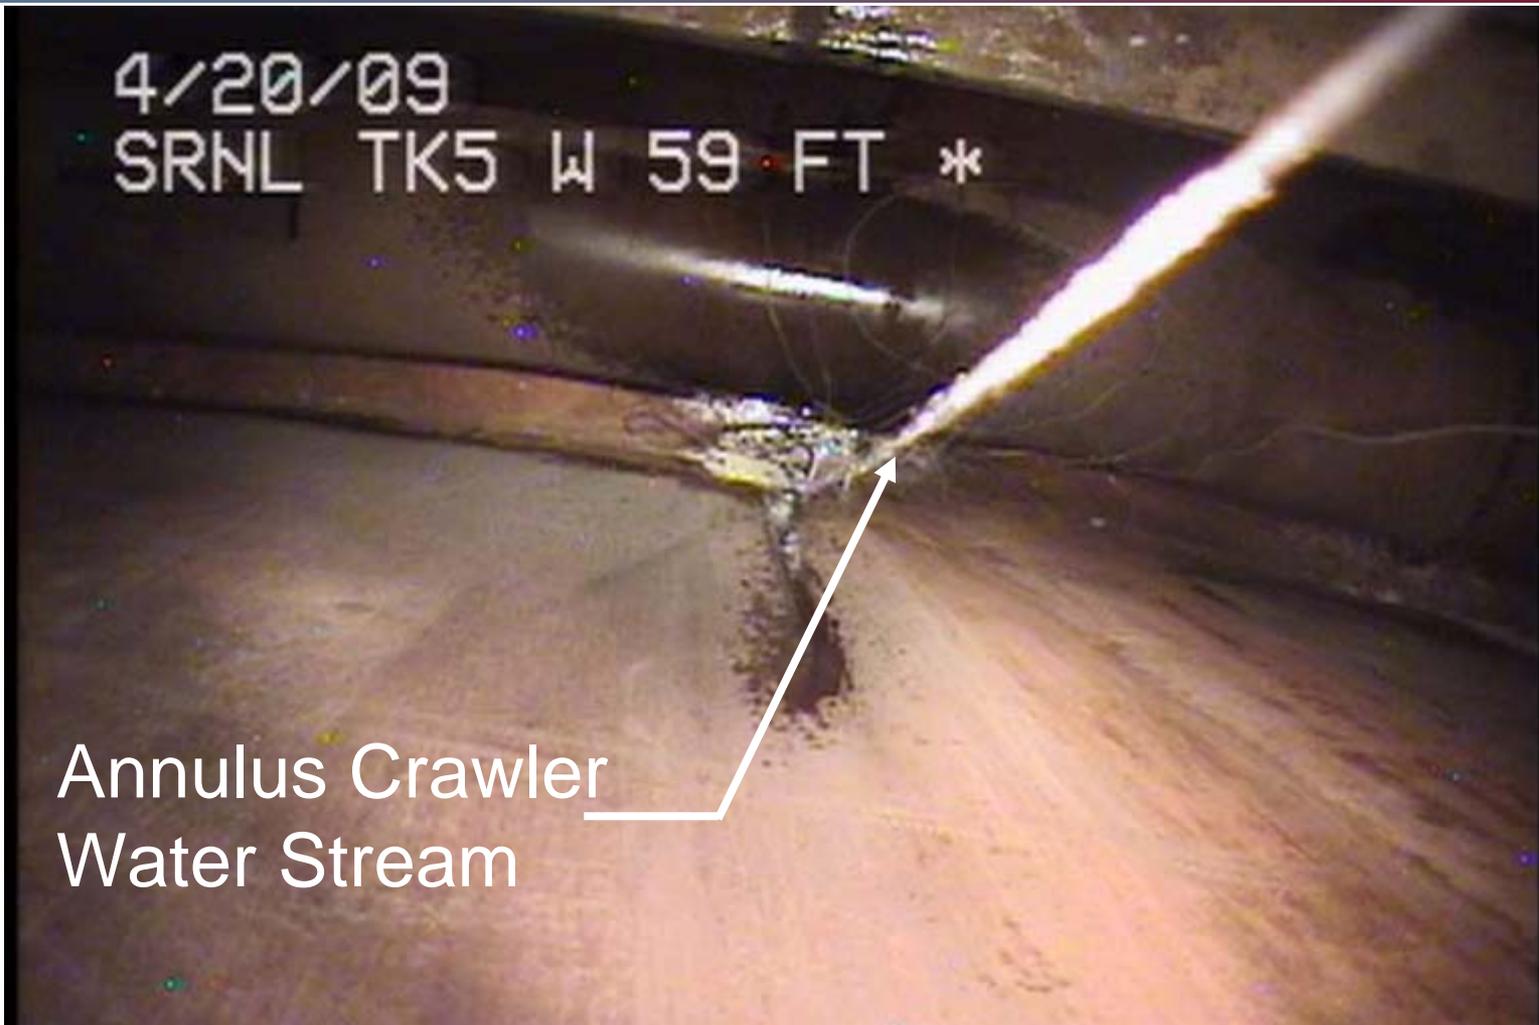
Tank 5 West Riser Leaksite (Cleaning)

Annulus Crawler
Water Stream

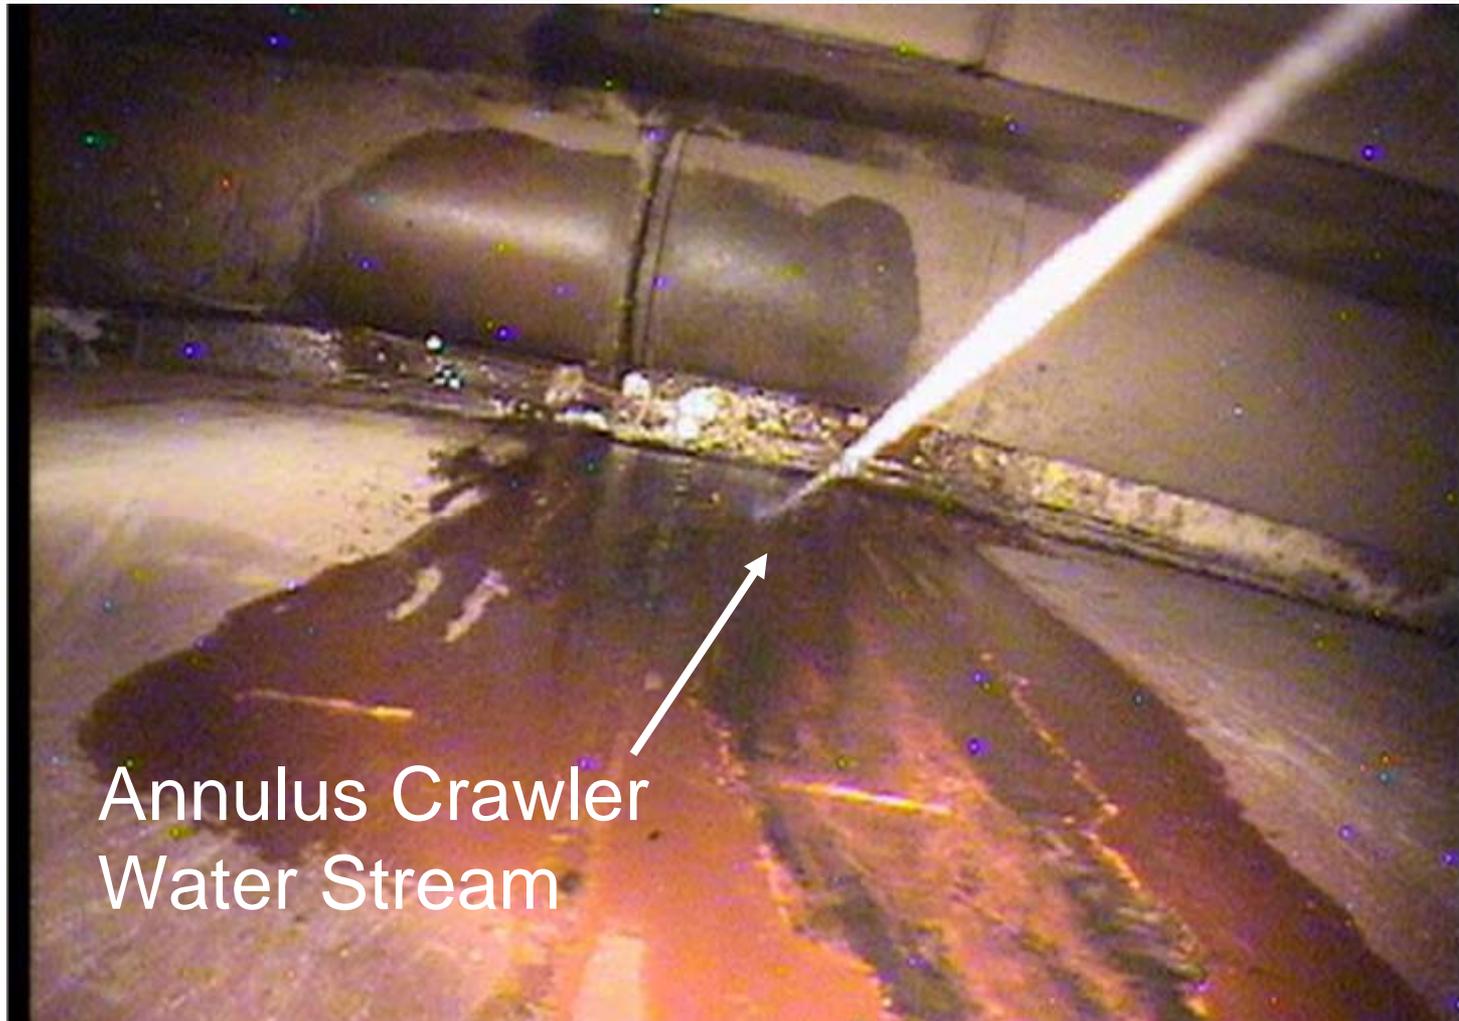
Tank 5 West Riser Leak Site (Cleaning)

Annulus Crawler
Water Stream

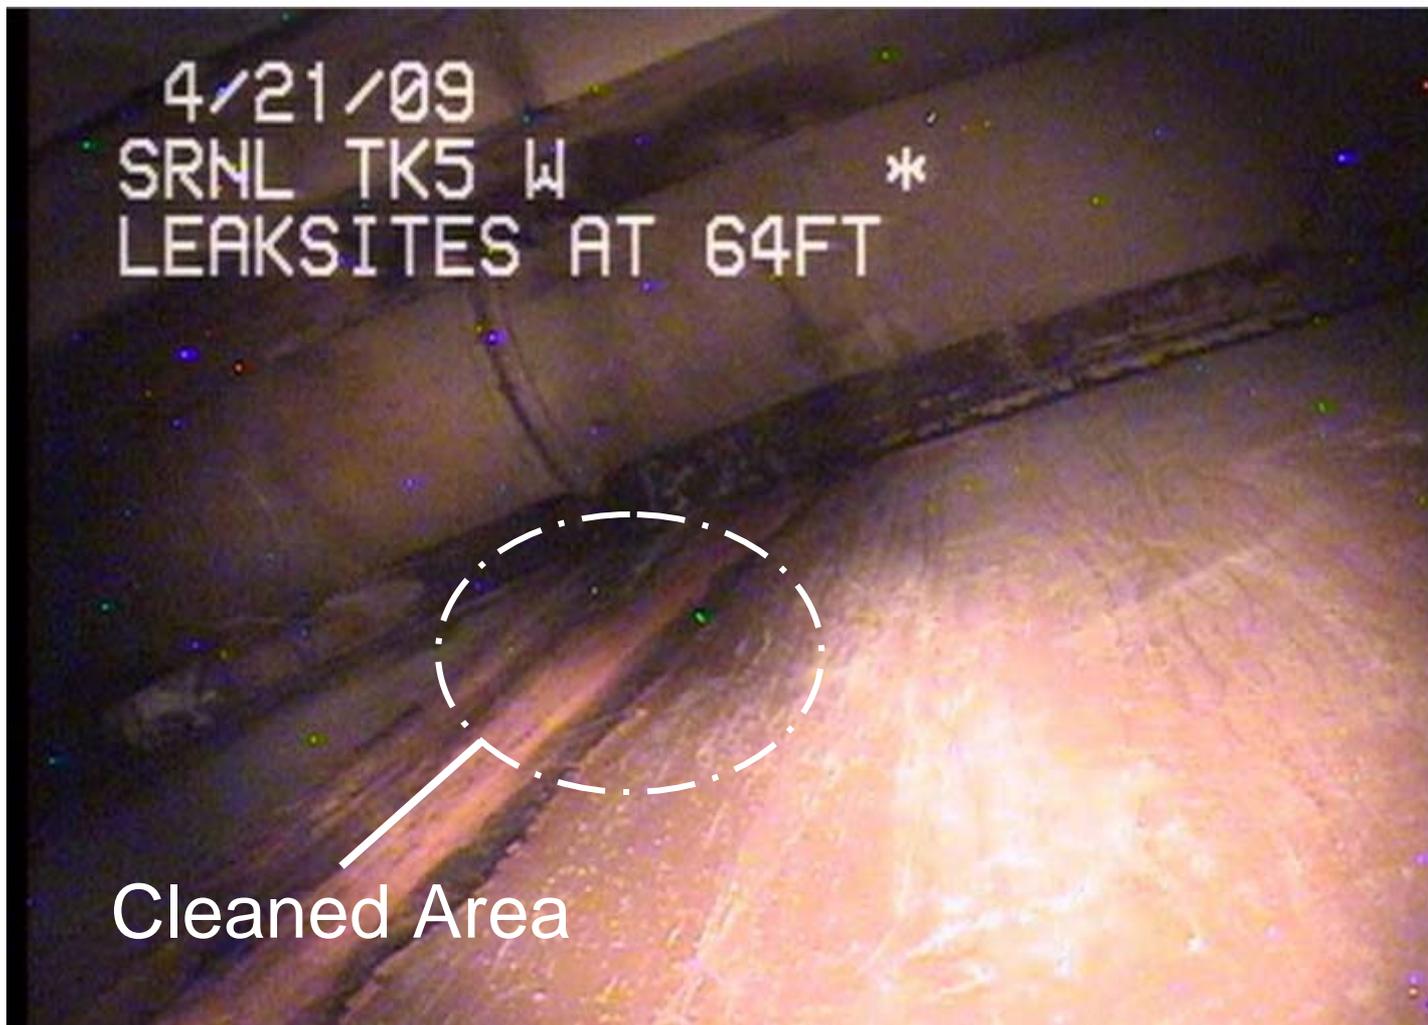
Tank 5 West Riser Leak Site (Cleaned)

Cleaned Area
