Saltstone LLW Processing Update

Aaron Staub
Senior Engineer
Waste Solidification Engineering
Denver Technical Exchange

LWO-WSE-2009-00135

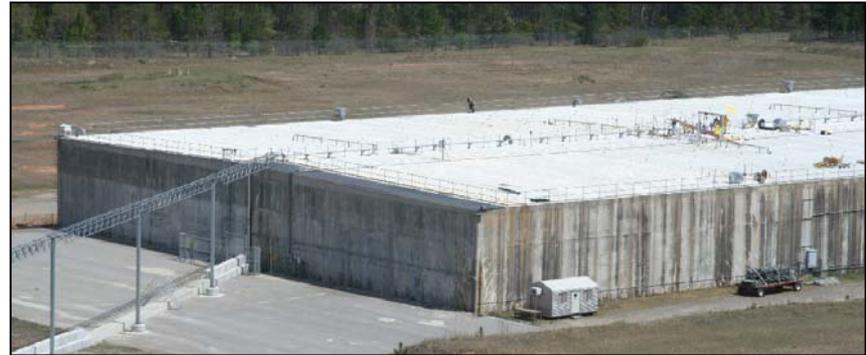
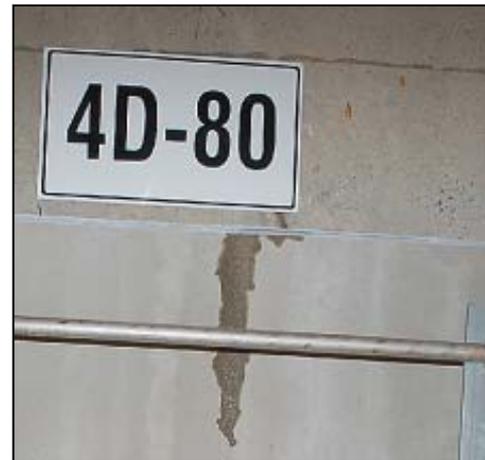
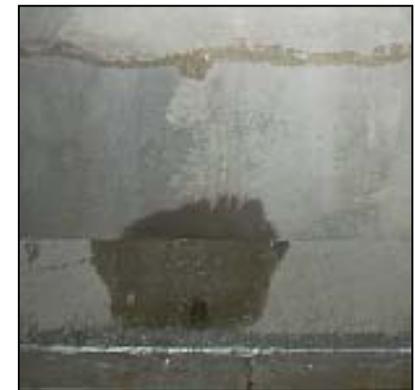
Challenge #1- Vault Wall Seepage

- Grout monolith to be self-supporting, design does not accommodate hydrostatic head beyond 5 ft
- Drain system retrofitted where possible to mitigate bleed water impacts
- Cells with marginal removal capacity are prone to seepage through cracks and construction joints
- Significant rework to mitigate impact of wet spots through contamination control and eliminate future seepage via surface treatment systems

- Surface treatments used to minimize wet spot formation
 - Combination of Xypex and Mega Mix II coatings
- Minimize opportunity for rainwater intrusion
 - Use of guards and ventilated enclosures
- Optimize grout formulation to minimize bleed water generation
- Future disposal cells will accommodate the static head caused by bleed water

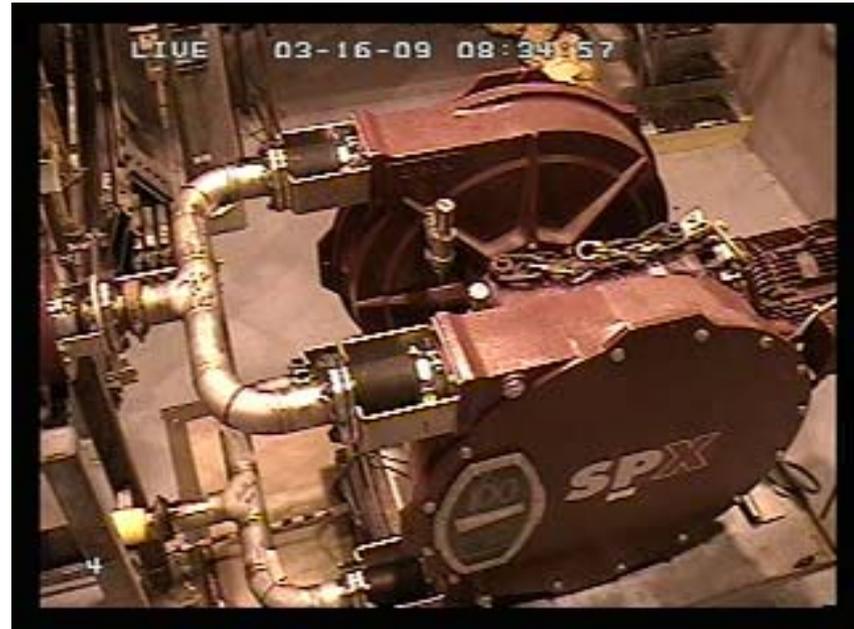
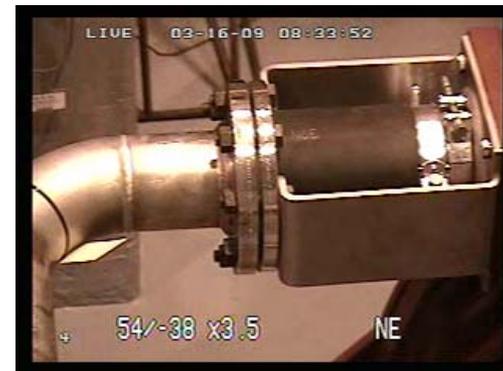
Challenge #2- Grout Pump Hose Failure

- Grout pump is duplex peristaltic pump- 10.5 gal/rev, nominal 140 gpm flow
- Chosen due to reliability, available suction head, use in industry, ability to handle abrasive slurries
- During processing, experienced a loss in pump efficiency followed by breach of hose integrity
- Subsequent diagnosis points to a suction starvation of west side hose, resulting in water hammer and hose abrasion

- Immediate implementation of pump efficiency metric with operator alarm (DCS calculation based off of pump speed, tank level change, and measured flow)
- Response procedure developed to allow for orderly shutdown

- Temperature measurement of pump head (RTD, IR camera, etc.)
- CFD modeling of suction piping, rework if improvements indicated

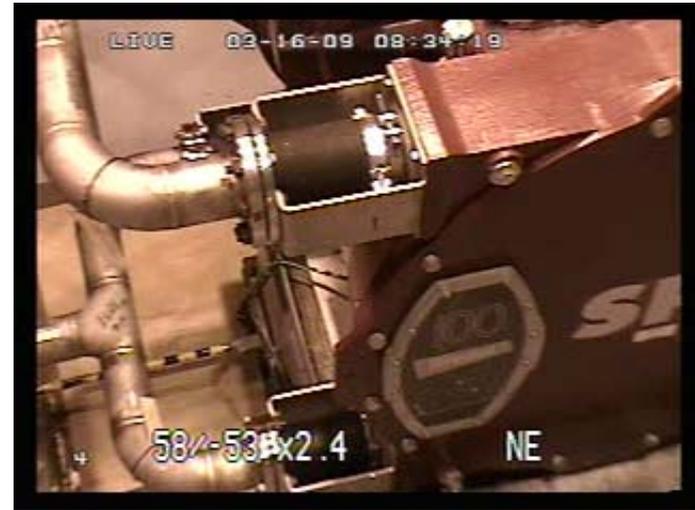
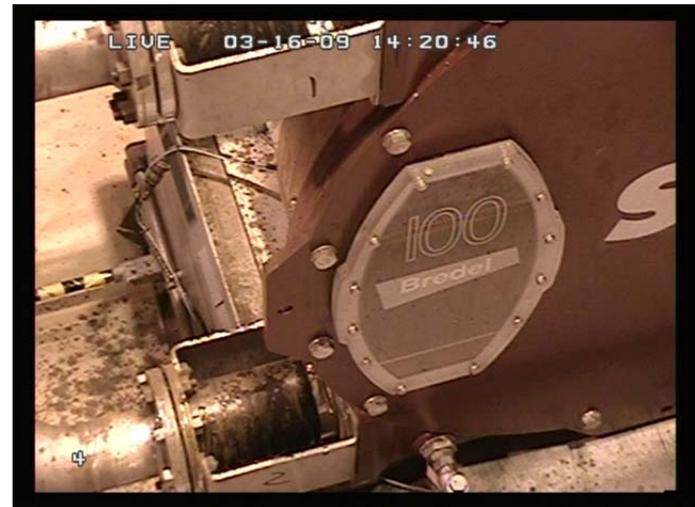
Challenge #2- Grout Pump Hose Failure

- Hose failure released ~15 gal of grout into pump casing and a smaller volume was widely dispersed throughout process room
- Required replacement of grout pump (~\$100k), loss of several days production, significant decontamination effort in process room
