Results of the 1000 Hour Rotary Microfilter Endurance Test

D.T. Herman - SRNL
W. Greene, J. Gilmour, T. Ho - SpinTek

EM Waste Processing Technical Exchange 2010

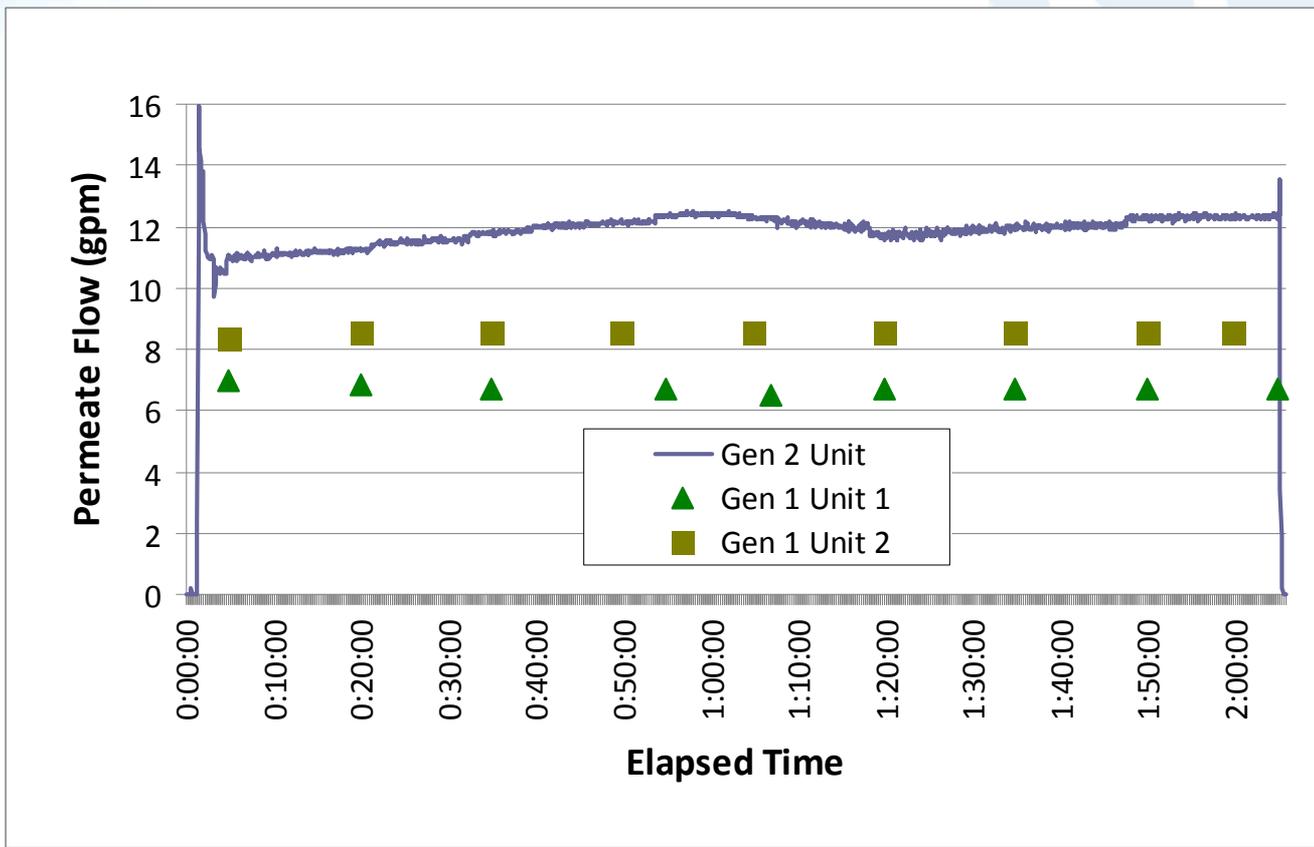
Acceptance Test - Clean Water Flux

The Gen 2 filter demonstrated ~50% improvement in clean water flux over the Gen 1 filters

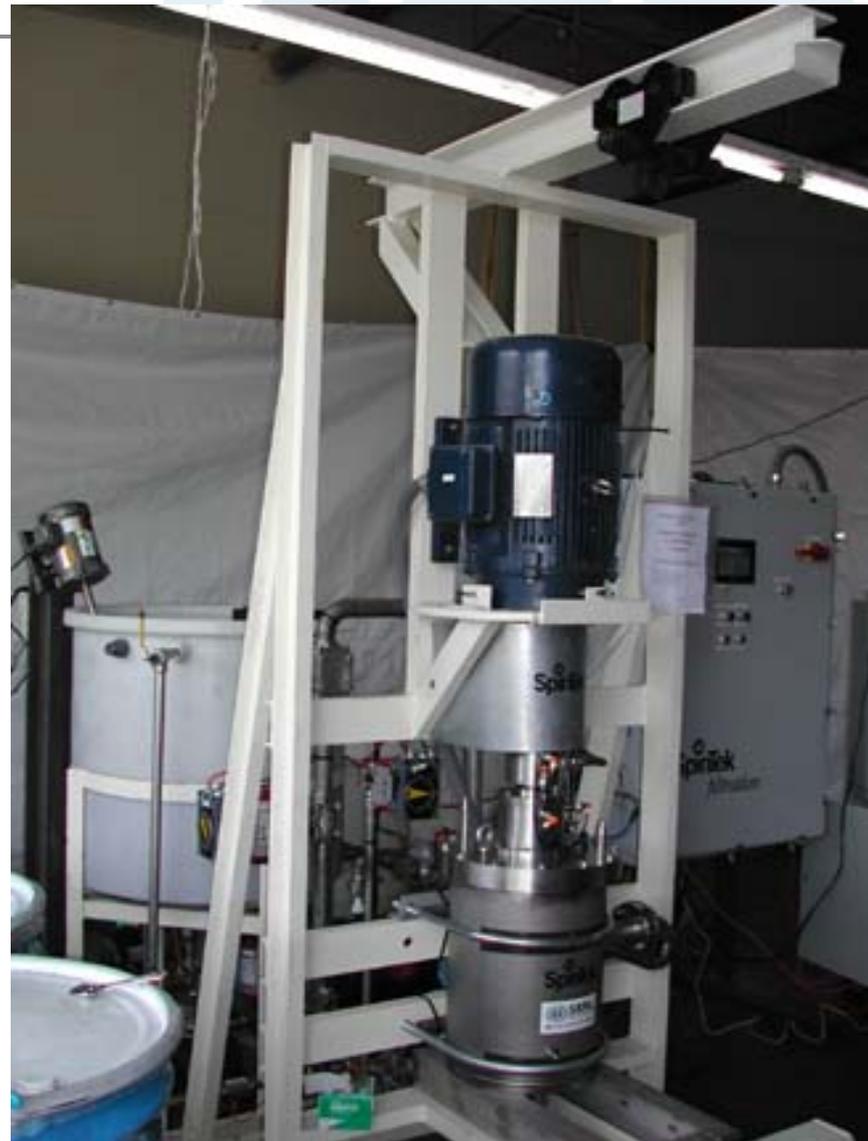
1000 Hour Test

Conducted at the vendor's facility

Sludge washing test

SRS Sludge Batch 6 recipe

- Slow settling
- Low mean particle size

3 sludge loadings – 5, 10, 15 wt %

Automated operation

After 1000 hours complete, sludge washed to <1M Na (initially 5.6M)

Testing completed in October 2010

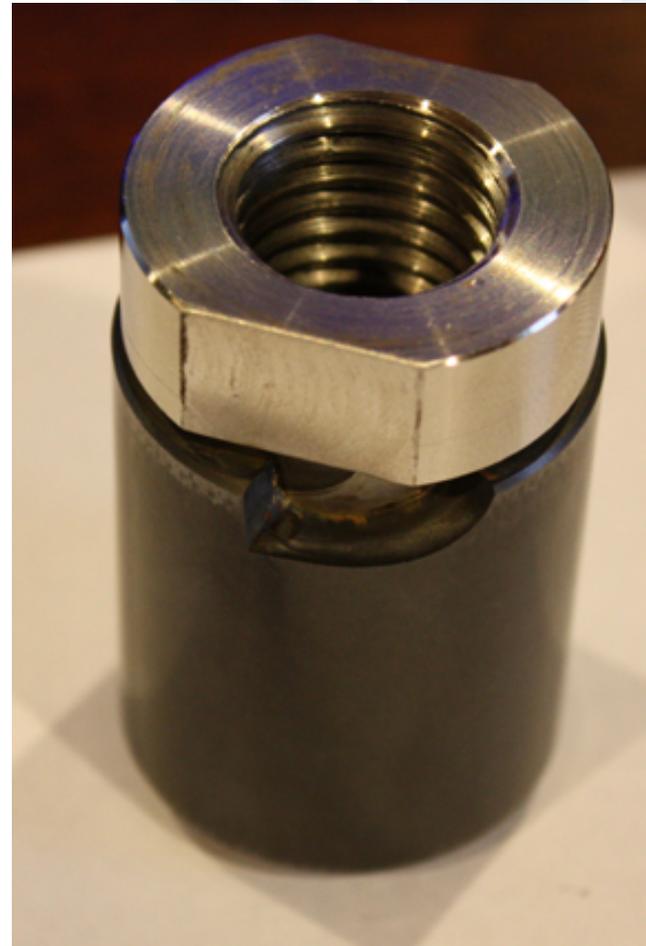
Journal Issue

- On two occasions, the filter stack was inspected during test shutdowns revealed chips in the silicon carbide journal bearing.
 - There was no operational evidence that the chips occurred
- Chips were located at stress risers (keyway and pin hole)
- Changed material from Silicon Carbide on Silicon Carbide to Stellite on Nitronic 60

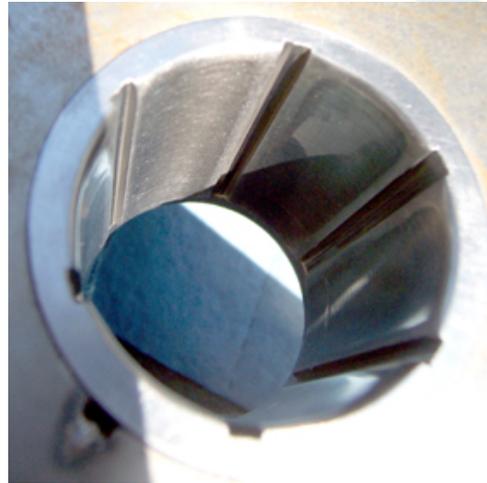
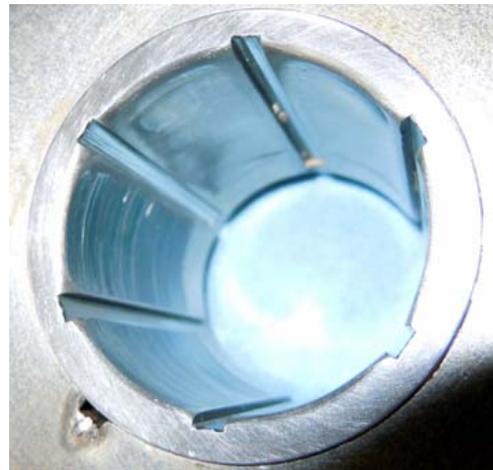
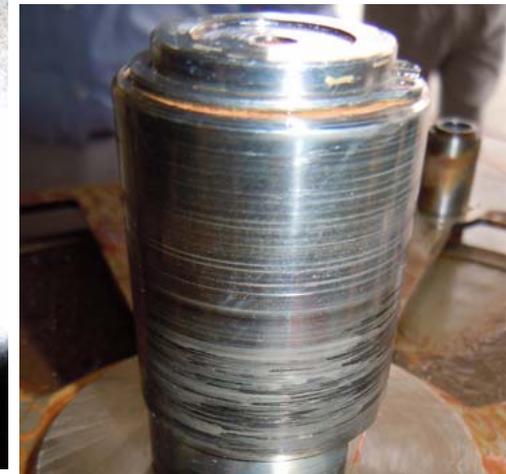
Bushing/Journal Bearing

- Initial clearance inadequate to support thermal expansion resulted in initial scarring of journal
- Tolerances adjusted and no journal issues were found during 1000 hour test

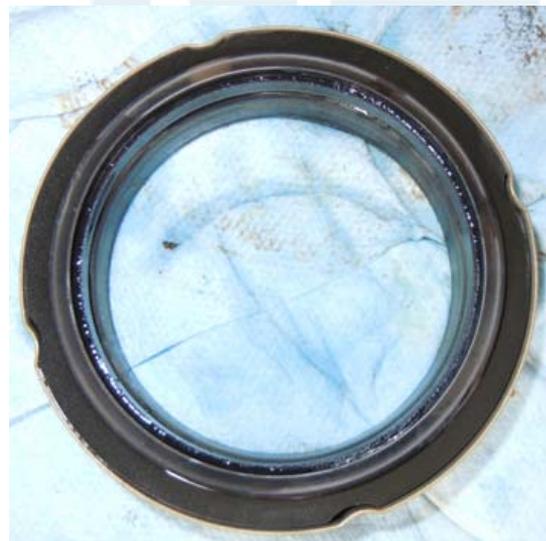
Rotary Joint Wear

- **Disassembly and inspection of the rotary joint seals showed no unusual wear**
- **No leakage observed during test**
- **Total operation time over 1500 hours**
